**BLUEMOUND ROAD
CORRIDOR:
ROAD SAFETY AUDIT**

Opus International Consultants Inc.

September 2007

H-U0008.00

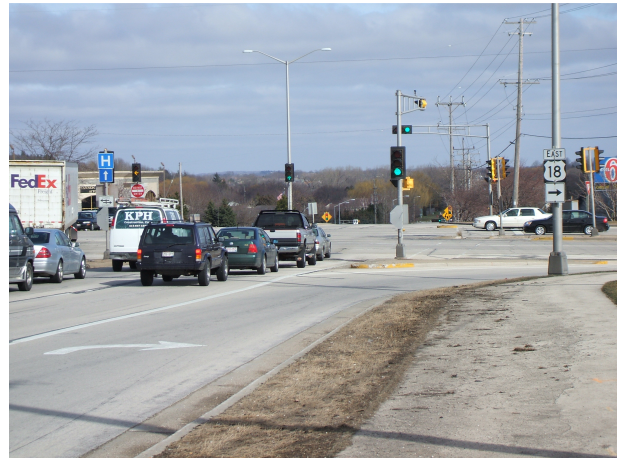
Right-turn Channelization Island on Northbound Barker

Safety Issue 1a: A high frequency of rear end right-turn crashes are occurring on northbound Barker as a result of limited sight distance due to the shape of the right-turn channelizing island.

Safety Issue 1a Description: A review of the crash data for the intersection of Barker and Bluemound indicated that 49 rear end crashes were occurring within the northbound right-turn channelization island. The first issue identified at the channelization island is the intersection sight distance between right-turners and approaching through traffic. The combination of a horizontal curve on Bluemound and the drivers requirement to look back impacts the sight distance.

Safety Issue		Suggestions
1a	1b	
√	√	<p>1. <i>Reconfigure the right-turn channelization islands to reduce turning radius</i></p> <p>Realigning the right turn channelization islands (<i>as shown on the right</i>) to reduce the turn radius, will reduce the unexpected stops and have the added benefits in terms of accommodating safer pedestrian crossings. It is noted that a redesigned right-turn channelization island must still be able to accommodate trucks and buses.</p>

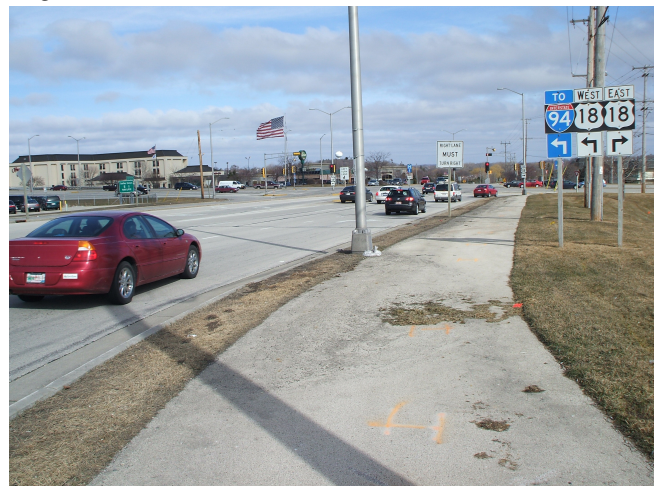
Weave Section between I-94 and Bluemound on Northbound Barker

Next, this right-turn channelization island was designed for a high speed right-turn, a Yield sign is present causing vehicles to unexpectedly slow down and yield for a gap in traffic. The crosswalk is located behind the point where vehicles are supposed to yield. When pedestrians are present, drivers typically have to slow down twice, once to yield for crossing pedestrians and the second time to yield to through traffic.

Finally there is a weave section on northbound Barker between the I-94 interchange and Bluemound Road. As a result drivers were observed weaving into the right-turn lane close to Bluemound Road and abruptly slowing down for either a crossing pedestrian or the yield sign.

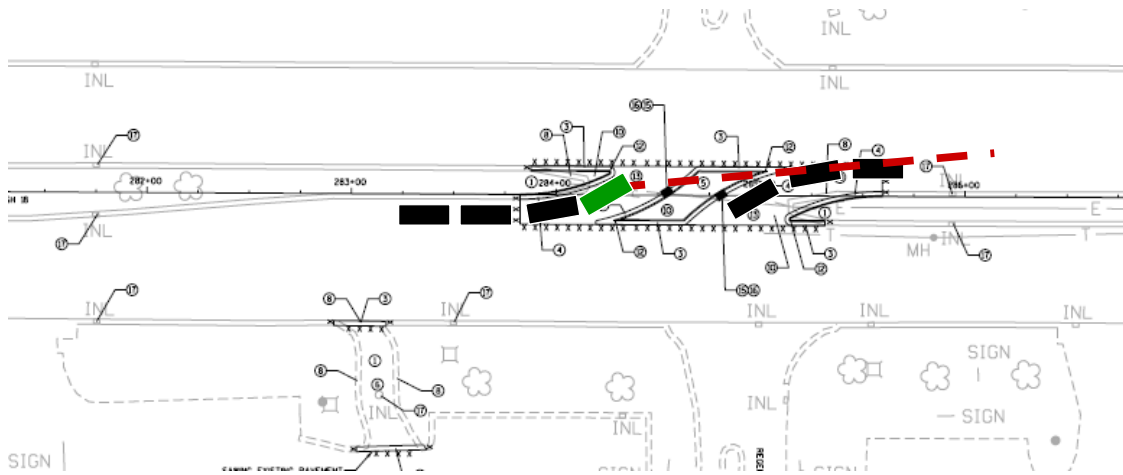
FIGURE 4.1 PROPOSED MEDIAN NOSE CONFIGURATION

Safety Issue 2 Description: Current design drawings indicate an extremely short distance between the opposing turn lanes within the dual restricted median openings. This layout can limit the view of opposing through traffic for drivers turning left or making a u-turn. Opposing vehicles waiting to turn left partly block sightlines between left-turn drivers and opposing through traffic (especially vehicles in the left through lane). This view of oncoming traffic can be further obstructed when a large truck is in the opposing turn lane. Drivers who cannot see approaching vehicles may attempt to turn left across the path of an oncoming vehicle, which may increase the risk of left-turn collisions. FIGURE 4.1 below illustrates this safety issue.

Increase the distance between the median openings to at least 100-feet and preferably 150-feet. This will enhance the sight distance for drivers looking to make left- or u-turn within the dual restricted median openings. By enhancing the sight distance the risk of left-turn and rear end collisions will be significantly reduced.

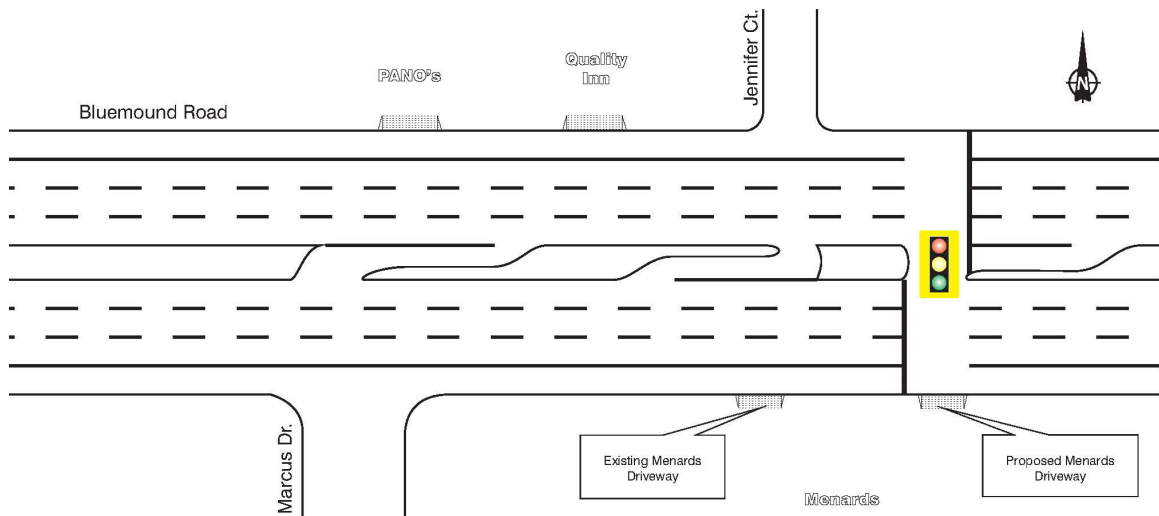
Bluemound Road near Marcus Drive

Safety Issue 3 Description: On westbound Bluemound Road the queue from the signal at Barker regularly extends 450 feet (according to the Earth Tech reports) which is beyond the existing signal at Marcus Drive. This was one of the reasons why the traffic signal at Marcus Drive is proposed to be relocated to the intersection of Bluemound and Jennifer.

Once the signal is relocated, eastbound drivers turning left at a median break into Pano's will have to cross four opposing lanes of traffic. This maneuver may generate eastbound left-turn and rear end conflicts with opposing through vehicles. The potential for collisions is further increased when drivers turn left through the traffic queued back from the signal at Barker Road. This in combination with the issues associated with the close proximity of the proposed dual restricted median openings which were discussed in Safety Issue 2, makes this eastbound left-turn movement a concern.

- ◆ Close the median opening for eastbound Bluemound into Pano's.
- ◆ Close the direct left-turn lane for Jennifer and create a single eastbound restricted median opening between Jennifer and Marcus.
- ◆ Move the proposed signal at Jennifer to the east so it is aligned with the northeast corner of the Menards parking lot.

These changes which are illustrated on the following page will provide reasonable access to all of the businesses along this section of Bluemound Road while eliminating the need for drivers to cross four lanes of opposing traffic through the queue for Barker Road. In addition this will increase the distance between this signal and the Barker Road signal which should help with the corridor progression. While this change may not be feasible for this project, it should be considered for the 2012 Bluemound Road reconstruction project.

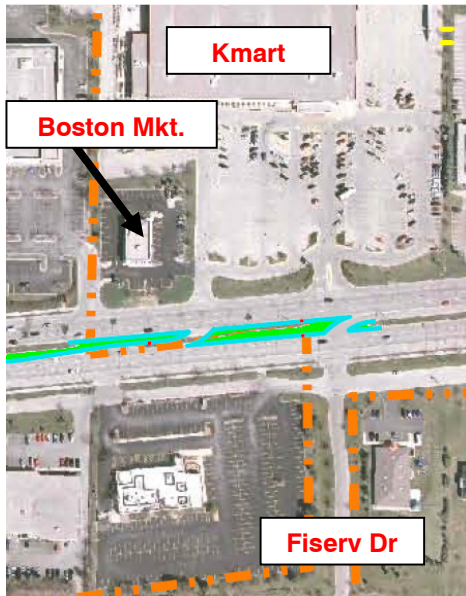
Bluemound Road near Fiserv Drive

Safety Issue 4 Description: Restricting access to these sites may cause drivers to take indirect routes, make U-turns at signalized intersections, or drive through parking lots, to reach the sites. Indirect routes may increase volumes on other roads that may not have sufficient capacity; U-turns at signalized intersections are illegal and may contribute to an increased risk of collision at the intersection (particularly with a conflicting right-turn movement); parking lots are not intended for through traffic, and through traffic, which is likely to be traveling at higher speeds, may conflict with pedestrians walking to and from their vehicles, and vehicles entering and exiting parking stalls. Locations in which these observations apply include:

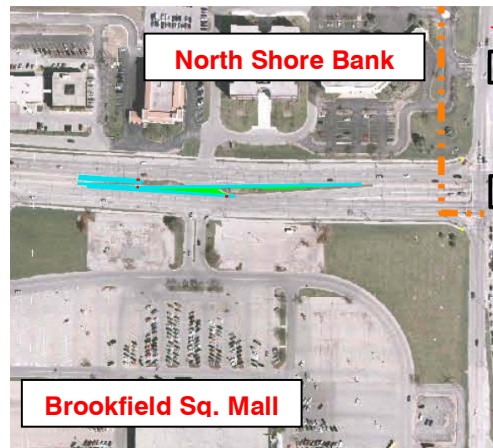
Bluemound Road near
Brookfield Square Entrance / North Shore Bank

- A history of angle and left-turn crashes within the existing median opening indicates that the opening is a safety issue;
- The close proximity of the median opening to two signalized intersections may result in interference with intersection operations;
- Limited space for left-turn storage availability for a median opening for North Shore Bank; and,
- Drivers turning left at the median opening through traffic queued at the adjacent intersection may conflict with opposing through traffic, particularly

when queued vehicles block sightlines between left-turn and through vehicles.

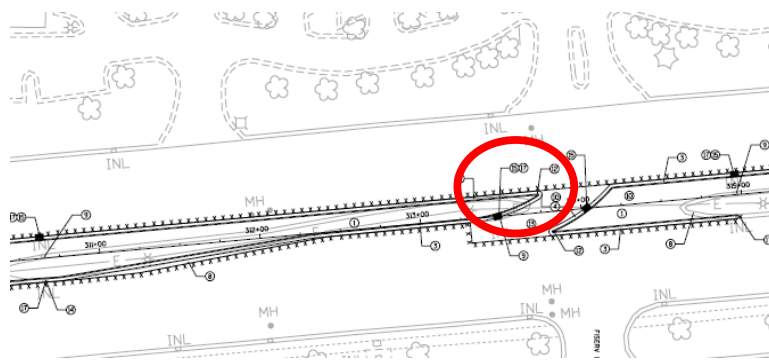
FIGURE 4.2 PROPOSED MEDIAN NOSE CONFIGURATION

Safety Issue 5a: With the changes in geometrics for the corridor, it is expected that the volumes of u-turning vehicles along the corridor will increase due to the elimination of many of the direct left-turn on to Bluemound Road. The proposed median nose configuration may orient vehicles to make left-turns. U-turns within the proposed median configuration may be more difficult due to the pointed median nose (*below*).

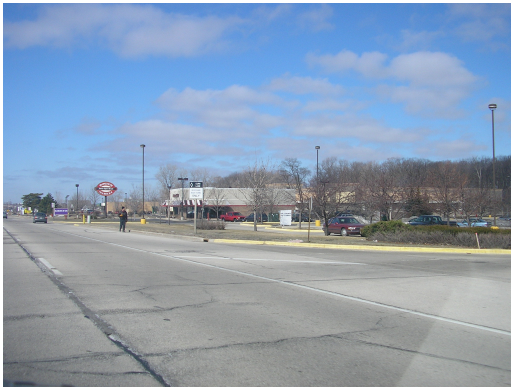
Pedestrian on the North Side of Bluemound Road

Safety Issue Description: The pedestrian facilities along Bluemound Road are incomplete. During site visits, moderate pedestrian volumes were observed. Pedestrian traffic appeared to be generated by the transit stops, office buildings, many strip malls and fast food restaurants. While continuous pedestrian facilities are provided on the south side of Bluemound Road, the network is not complete on the north side. As a result, pedestrians were observed walking in the street and crossing at locations where drivers do not expect to see pedestrians.

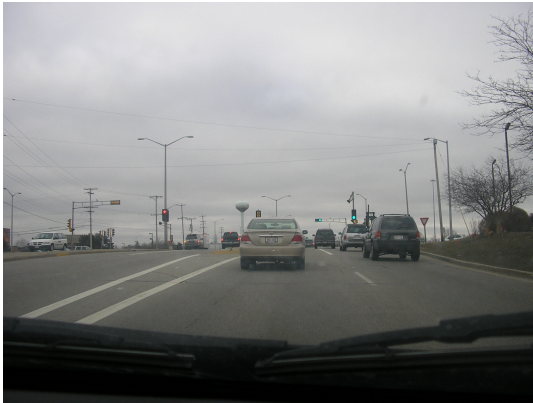
Southbound Barker at Bluemound

Safety Issue 7 Description: The use of a single overhead signal head limits signal (and intersection) conspicuity for drivers approaching the intersection, and may limit signal visibility for drivers whose view of the single overhead display is compromised by a tall vehicle (such as a truck) ahead, or affected by a bright rising or setting sun. The risks associated with limited signal and intersection conspicuousness is greatest at the intersection with Barker Road, where drivers' view of the intersection on several approaches is limited by vertical and horizontal curves. Drivers who fail to observe the signal display increase the risk of angle and rear-end collisions. The risk is also increased for older drivers, whose visual and decision-making abilities are reduced.

1. *Provide a redundant signal display on each approach.* The use of multiple overhead signal displays on a single approach enhances signal conspicuity, provides redundancy in the event of signal failure or damage, and may improve signal visibility. Redundancy may be achieved by providing multiple signal overhead heads (such as one signal head over each approach lane).

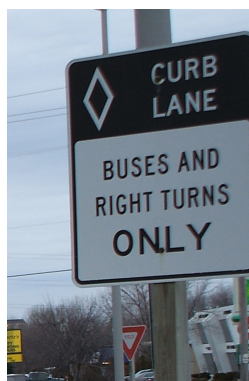
Existing Sign Design

The existing curb lane signs do not allow for bicycles. As these signs will be replaced due to changes in the MUTCD with regards to diamond lanes, the audit team reviewed the existing sign design and a proposed sign design. The existing sign design utilizes text to allow buses and right turns only.
