# **BURLINGTON BYPASS: ROAD SAFETY AUDIT**

Opus International Consultants Inc.

November 2006

H-08147.00

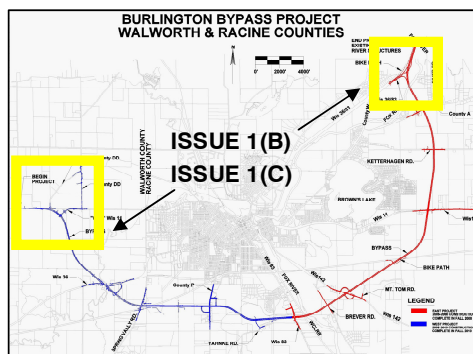
**Safety Issue 1(a) Description:** The Bypass follows a semi-circular alignment that incorporates many horizontal curves (*right*). The presence of frequent horizontal curves, even if compliant with AASHTO criteria, can be expected to result in an increased risk of run-off-road collisions when drivers fail to follow a changing alignment. Aggravating factors include:

- the high speed environment (mainline design speed of 60 mph and posted speed of 55 mph),
- the limited use of lighting,
- the possibility of fog associated with the surrounding wetlands and streams,
- the potential presence of wildlife on the road in this rural area.

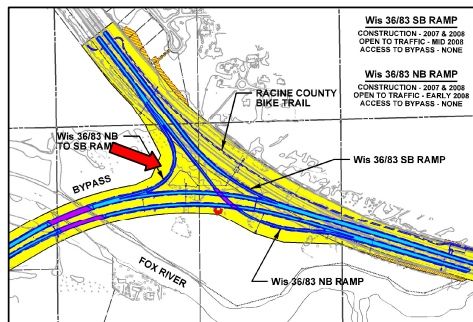
**Safety Issue 1(b):** At the north interchange (*right*) of STH 36/83 and the Bypass, a tight ramp configuration may result in an increased risk of run-off-road (lane departure) crashes.

**Safety Issue 1(b) Description:** Severe constraints at the eastern end of the Bypass have resulted in a ramp design based on a design speed of 30 mph and posted speed of 25 mph. The ramp connects two roads (STH 36/83 and the Bypass) having posted speed limits of 55 mph. Drivers who fail to slow sufficiently on the ramp have an increased risk of off-road crashes and, in the case of trucks, rollovers. Aggravating factors contributing to an increased risk of collision include:

- possible icy pavement on this section of road, which is on structure;
- a high driver workload on the ramp, where entering drivers must merge with higher-speed traffic on the through route while navigating a reverse curve.

</li> <li>○ A W13-3 (Advisory Ramp Speed) sign may be used on the ramp to advise drivers of the slower speed limit.</li> <li>○ W4-1 (Merge) signs may be used on the ramp and mainline to advise drivers that ramp traffic must merge at the ramp terminus.</li> </ul> <p>Posting a large number of warning signs on the ramp and its approach may contribute to a high driver workload as drivers attempt to understand the signs, adjust their speed appropriately, and accomplish a safe merge. Prioritization of the hazards on the tight curve, and the resulting signing requirements, may be beneficial.</p>

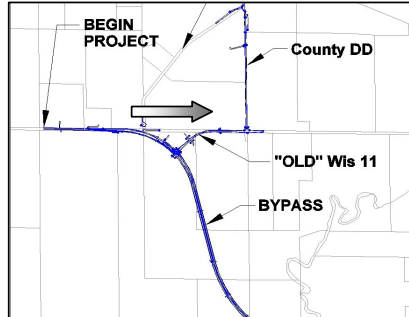
**Safety Issue 1(c):** At the west end of the project, drivers may expect to follow the abandoned alignment of STH 11, resulting in an increased risk of off-road (lane departure) crashes.

**Safety Issue 1(c) Description:** The design team has diverted the existing STH 11 alignment to intersect the new Bypass alignment at a right angle (*right*). Vestiges of the old alignment such as pavement, landscaping, or a roadside utility corridor may confuse inattentive eastbound drivers. Drivers who follow the old alignment may enter the opposing lanes of traffic or the roadside.

**Expected Crash Types:** run-off-road collisions

**Expected Frequency:** occasional

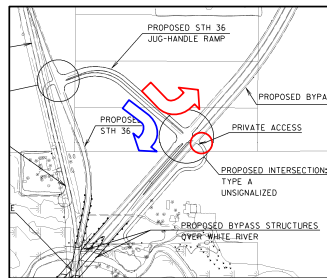
**Safety Issue 3(a): A high left-turn volume onto the Bypass ramp at STH 36 may increase the risk of rear-end and left-turn collisions on the Bypass.**

**Safety Issue 3(a) Description:** Traffic forecasts show a high left-turn volume from the SE STH 36 ramp on to the Bypass (*red arrow, right*). The high turning volume at this unsignalized intersection can be expected to increase the collision risk due simply to volume-related exposure. The risk and potential severity of collisions is increased by high approach speeds (posted speed 55 mph) on the Bypass.

The intersection complexity is increased by the presence of a private access that forms a fourth intersection leg (*red circle, right*). In the present design, vehicles turning into or out of the private access are accommodated only by a short taper for left-in movements. Accelerating or decelerating vehicles associated with this private access may interfere with through traffic on the Bypass, increasing the risk of collision. Currently, the risk is limited by low volumes on the private access, but future development may result in higher volumes and a higher risk.

Interference between right-turn movements from the ramp (*blue arrow, above*) and through traffic on the Bypass can also be anticipated, since a limited deceleration and acceleration taper is provided on the Bypass.

- An offset right turn lane (example at right) on the Bypass may be considered. The offset lane would provide a longer deceleration distance for drivers turning right onto the ramp, and would position these decelerating vehicles further right to reduce interference with sightlines between through traffic on the Bypass and drivers entering the Bypass (turning either left or right).

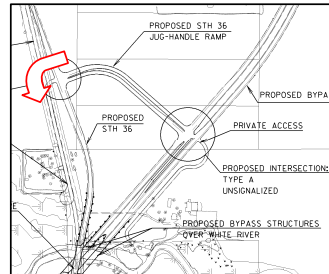
**Safety Issue 3(b): A high left-turn volume from the Bypass ramp onto STH 36 may increase the risk of rear-end and left-turn collisions on STH 36.**

**Safety Issue 3(b) Description:** Traffic forecasts show a high left-turn volume from the Bypass ramp onto southbound STH 36 (right). The high turning volume at this unsignalized intersection may cause queuing on the ramp (where sight distance is limited by a horizontal curve for drivers exiting the Bypass), and an increased risk of left-turn collisions on STH 36. The risk and potential severity of collisions is increased by high approach speeds (posted speed 55 mph) on STH 36.

**Suggestion:** Install a signal or roundabout at the ramp intersection. The introduction of a signal at the intersection of STH 36 and the ramp may be considered if WMUTCD traffic signal warrants are satisfied. Alternatively, the design team may consider providing a roundabout at this intersection to accommodate the substantial through and left-turn volumes. A preliminary review suggests that sufficient right of way is available to accommodate a roundabout.

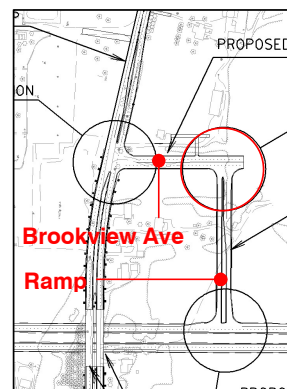
**Safety Issue 3(c): Substantial turning movements at the intersection of the CTH P ramp and Brookview Avenue may lead to turning conflicts and queuing on the ramp.**

**Safety Issue 3(c) Description:** The CTH P ramp intersects Brookview Avenue at a "T" intersection (red circle, right). Traffic forecasts show a substantial volume on the ramp and Brookview Avenue, reflecting existing demand as well as future development of an industrial park on the site adjacent to the intersection. All-way STOP control at the intersection may lead to substantial delays, resulting in undesirable queuing on the ramp. Two-way STOP control, which would likely require drivers exiting the industrial park and drivers on Brookview Avenue to stop, may result in driver confusion when stopped drivers fail to anticipate that the ramp approach is uncontrolled.

**Suggestion:** *Install a roundabout at the “T” intersection.* The design team may consider providing a roundabout at this intersection to accommodate the substantial through and turning volumes on the ramp and Brookview Avenue. A preliminary review suggests that sufficient right of way is available to accommodate a roundabout. Although the industrial park is not expected to be developed until after completion of the Bypass, construction of a roundabout at the time of Bypass construction may be less costly than future re-configuration of the “T” intersection.

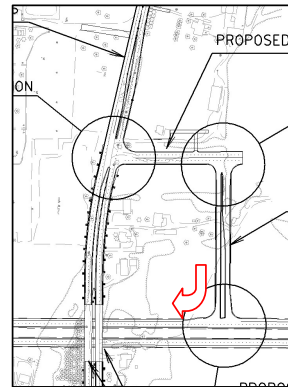
**Safety Issue 3(d): Drivers turning right from the CTH P ramp may interfere with through traffic on the Bypass.**

**Safety Issue 3(d) Description:** Interference between right-turn movements from the ramp (*red arrow, right*) and through traffic on the Bypass can be anticipated, since a limited deceleration and acceleration taper is provided on the Bypass. Interference between right-turning and through traffic is likely at this intersection, since the ramp provides access to trucks (which typically have slow acceleration characteristics) associated with the JW Peters Quarry and the future industrial park.

**Suggestions:** A parallel acceleration lane on the Bypass for right-turning traffic may be considered to allow right-turning drivers to accelerate for a longer distance before merging into the right Bypass lane. At this location, a longer acceleration lane may require widening of the adjacent overpass structure.

An offset right turn lane (*example shown above under Safety Issue 3(a)*) on the Bypass may be considered. The offset lane would provide a longer deceleration distance for drivers turning right onto the ramp, and would position these decelerating vehicles further right to reduce interference with sightlines between through traffic on the Bypass and drivers entering the Bypass (turning either left or right).

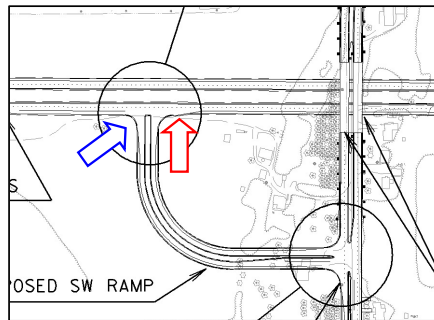
**Safety Issue 4(a): Auxiliary lane lengths at five ramps appear to be short, and ramp entry turn radii appear to be abrupt.**

**Safety Issue 4(a) Description:** Five interchange ramps or intersections include short right-turn acceleration lanes (usually of a tapered design), often limited by adjacent structures or upstream features. The short tapered acceleration lanes limit right-turning drivers' ability to accelerate to highway speed before merging into the right through lane. Slower vehicles, especially slowly-accelerating trucks, may interfere with through traffic on the Bypass, increasing the risk of rear-end and sideswipe collisions. Drivers who fail to merge may leave the travel lane, resulting in off-road and fixed-object collisions.

**Example (ramp at CTH P and the Bypass):**  
A short acceleration lane is provided (red arrow, likely due to the overpass structure), and the right-turn radius onto the ramp (blue arrow) appears to be abrupt.

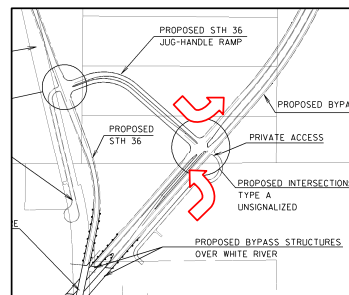
**Safety Issue 4(b) Description:** Three ramp or road intersections involve an unprotected left turn across two lanes of opposing or crossing Bypass traffic. The risk and potential severity of left-turn crashes is aggravated by:

- high speeds on the Bypass
- forecast high left-turn volumes at CTH A and STH 36 ramps, which increases exposure
- absence of night-time lighting
- a high proportion of trucks (with slower acceleration and braking capabilities) in forecast Bypass and ramp traffic
- winter road conditions (contributing to poor acceleration and braking capabilities) and the potential for fog (contributing to limited sight distance) in low-lying areas around rivers.

**Example (ramp at STH 36 and the Bypass):** Left turns from and onto the ramp must cross two lanes of Bypass traffic.

Signalization of ramps may be considered, but the addition of two signals to the Bypass may be operationally undesirable. Although signalization remains an option, three alternative suggestions can be considered by the design team:

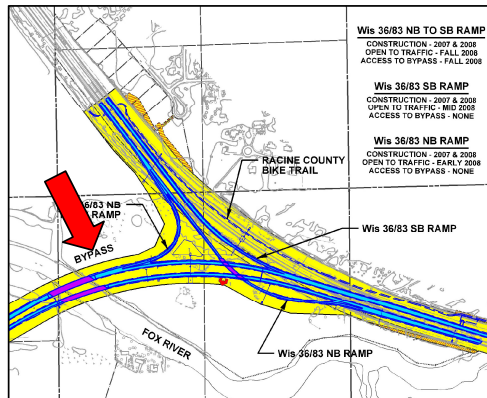
**Safety Issue:** A required merge on a horizontal curve contributes to a high driver workload at the north interchange.

**Safety Issue Description:** Drivers entering the Bypass from Hwy 36/83 enter a reverse curve (*right*) before encountering a required merge movement on segment of roadway having horizontal and vertical curves. The merge will take place on a bridge over the Fox River, where icy pavement and foggy conditions may prevail. The challenging geometric features are in part the result of severe constraints reflecting limited right-of-way and environmental limitations.

Acceleration and merging on a curved roadway contribute to a high driver workload, which may be aggravated by poor visibility or pavement conditions due to fog or ice. In addition to the challenging geometry of the ramp, proposed guide signing provides a large amount of information that drivers must process as they navigate the curve and merge.

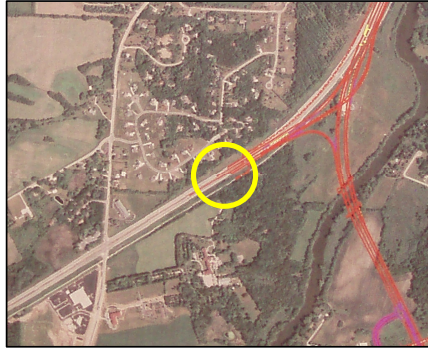
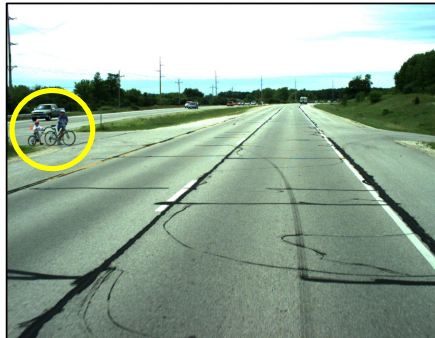
**Safety Issue Description:** The new north interchange will require relocation of an existing County bicycle trail from the south side of STH 36/83 to the north side of the highway. Bicyclists will be directed to an at-grade mid-block crossing over STH 36/83 (*right*), where they will cross a divided four-lane highway having a posted speed of 55 mph.

The risk of collision is increased by the high speeds, the need to cross multiple lanes (*right*), absence of lighting, potentially high proportion of trucks (which have reduced braking ability), and the possible presence of young and/or inexperienced cyclists on the County bike trail.

1. *Relocate bicycle crossing:* The design team may consider relocating the planned bicycle trail crossing from its proposed location to the signalized intersection at CTH W (red circle at right). Relocation of the crossing would allow cyclists to cross with the signal at a lighted intersection, where drivers may more readily expect and see them.

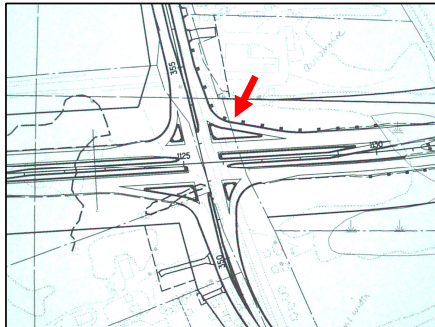
**Safety Issue 6(b): A guardrail obstructs pedestrian access to a signalized intersection.**

Design drawings show a continuous guardrail in the northeast corner at the intersection of the Bypass with STH 83. The guardrail obstructs pedestrian access to the intersection, which has pedestrian crossing facilities.

2. *Provide barrier break to allow pedestrian access.* Design drawings may be amended to provide a crashworthy break in the barrier at the STH 83 intersection to allow pedestrian access to the intersection without compromising the performance of the barrier in a crash. Pedestrian visibility should be considered in the redesign of the barrier.

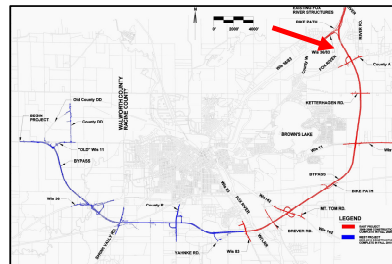
**Safety Issue: Icy and foggy conditions may aggravate the risk of collisions.**

- *Icy Pavement:* Since bridges typically freeze before adjacent road segments on grade, drivers may fail to anticipate icy conditions on bridges. The risks associated with a slippery road surface are substantial at the north interchange bridge (*red arrow, right*), as described under Issue 5 above.
- *Foggy Conditions:* Foggy conditions can be frequently encountered in wetland and river areas. Visibility may be unexpectedly and intermittently reduced in foggy areas.

<b>Expected Crash Types:</b>	off-road collisions
<b>Expected Frequency:</b>	occasional
<b>Expected Severity:</b>	high
<b>Risk Rating:</b>	D (moderate-high risk level)
