USH 41 EXPANSION -WINNEBAGO COUNTY:

ROAD SAFETY AUDIT

November 2007

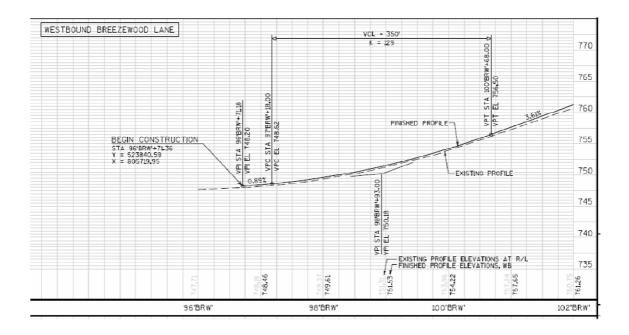
SB Koeller & 9th Avenue

Limited vertical sight distance on roundabout approaches

Several of the roundabouts throughout the corridor are planned for locations where they will be located on the crest of a vertical curve. These locations will provide for limited sight distance on the approaches which may increase the risk of rear-end collisions on the roundabout approaches. While the vertical sight distance to the existing signalized intersections is not necessarily adequate, drivers have the benefit of being able to see the overhead signal mast arms on the approaches

The photo (right) illustrates an example of an intersection with existing sight distance restrictions on the approaches location. The below figure illustrates the proposed vertical curve on the approach to a roundabout at Breezewood Lane.

Safet	y Issue	Suggestions	
1b	1c		
V	\checkmark	<i>Flatten the vertical curves:</i> Reducing vertical and horizontal grades will improve sight distance and provide drivers with increased reaction time.	
V	V	<i>Lighting on the approaches:</i> Lighting is generally considered beneficial at intersections to improve sight distance and night-time visibility. It is suggested that lighting be provided on all roundabout approaches which include horizontal and vertical curves.

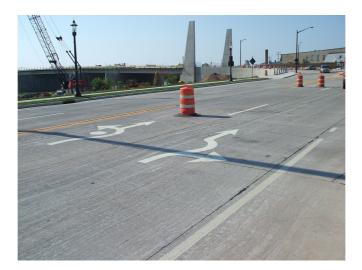
Left-turn pavement arrows

The use of left-turn arrows in roundabouts may encourage unfamiliar drivers to make wrong way maneuvers on to the roundabouts. From a human factors perspective, utilizing left-turn pavement violates driver expectancy.

"Fish-hook" arrows: The proposed "Fish-hook" arrow design for signs and markings *(below)* can be used for driver guidance on the approaches to roundabouts. The WisDOT Northeast Region is already utilizing this arrow design on the Claude Allouez Roundabout in De Pere on STH 57 *(below)*.

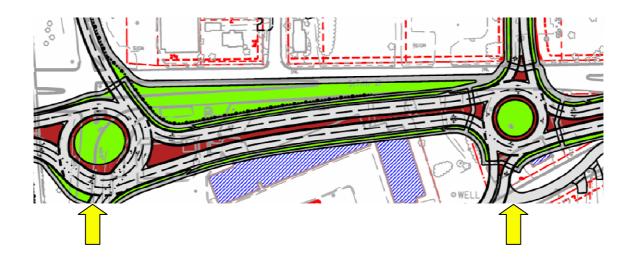
Raised Non-Circular Apron:

The central islands of several roundabouts utilize a raised non-circular apron. While the non-circular shape is critical when utilizing spiral striping, the raised non-circular shape may cause drivers to hit the curb or drift out of the lane due to the inconsistency with neighboring roundabouts. Additionally, once roundabouts open it is not uncommon for the road agency to have to make minor modifications to the pavement markings. By providing a raised non-circular apron, it will be more difficult and expensive to make minor modifications to the roundabout.

Expected Crash Types:	fixed object and weaving collisions
Expected Frequency:	occasional
Expected Severity:	low
Risk Rating:	B (low risk level)

Implement circular aprons: Circular aprons may be used at all roundabouts for consistency. Pavement markings can be used to align or add lanes around the apron *(right)*. Pavement markings are a low cost application method to make minor modifications to the apron.

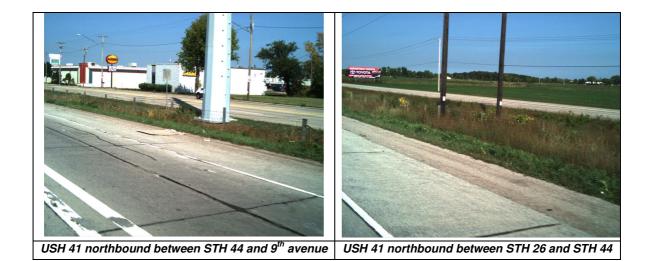
Utility poles close to USH 41 and Frontage Roads

Utility poles adjacent to northbound USH 41 and the east frontage road are located within the clear zone. Due to their proximity to the roadway, drivers are likely to strike one of these fixed objects if they lose control and depart the roadway. The severity of these crashes is increased due to the high speeds which vehicles are traveling on USH 41. If a vehicle traveling at high speeds strikes a utility pole, a severe crash may occur.

Expected Crash Types:	head-on and fixed object collisions
Expected Frequency:	occasional
Expected Severity:	high
Risk Rating:	D (significant risk level)

- 1. *Relocate utility poles:* Relocate utility poles out of the clear zone to reduce the possibility of fixed object collisions between vehicles and the utility poles.
- 2. Provide barrier protection of fixed objects: If relocating the utility poles is infeasible, it is suggested that a barrier such as guardrail be provided to shield the fixed object. Guardrail will decrease the severity rating and the possibility of a severe injury due to a fixed object collision.
- 3. Provide cable guard rail or barrier: To prevent vehicles from crossing over the median between USH 41 and the frontage roads, it is suggested that cable guard rail or barrier be considered. Cable guard rail or barrier will help to prevent head-on collisions related to these median crossovers.

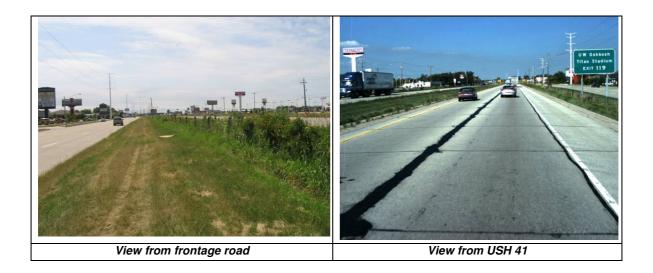
Close spacing between USH 41 and frontage roads

Due to the close proximity of USH 41 to the frontage road, vehicles which lose control and exit the roadway may cross over the median resulting in head-on collisions. This close proximity is present on several sections of the corridor.

Expected Crash Types:	head-on and fixed object collisions
Expected Frequency:	occasional
Expected Severity:	high
Risk Rating:	D (significant risk level)

4. *Edgeline rumble strips*: It is suggested that shoulder rumble strips be used on the corridor. It is also suggested that these rumble strips be supplemented by painting edgelines over the rumble strips. The presence of paint on the vertical rumble strip faces provides enhanced delineation, particularly during wet weather.

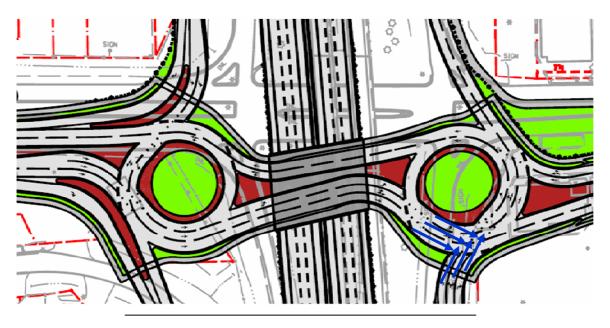
Conflicts between northbound USH 41 off-ramp and eastbound STH 21

Three lanes of traffic on the USH 41 northbound off-ramp may conflict with three lanes of traffic traveling eastbound on STH 21 through this roundabout. This potential conflict is of concern due to the potential for eastbound STH 21 to operate in more of a free flow condition due to the low volume of traffic which will be within the roundabout when it enters. This will likely increase speeds for traffic on eastbound STH 21 within the roundabout and decrease available gaps for drivers entering the roundabout. Due to these higher than expected speeds and fewer than expected gaps, drivers may choose inopportune times to enter the roundabout.

Additionally, the proposed three lane entrance is likely to generate intersection sight distance restrictions for drivers in the right lane on the USH 41 northbound off-ramp. It will likely be extremely difficult for drivers within this lane to see traffic within the roundabout and choose an inadequate gap to enter the roundabout. Sight distance will be further decreased if a large truck or van is stopped in the left or center lane.

Expected Crash Types:	angle and sideswipe collisions
Expected Frequency:	occasional
Expected Severity:	low
Risk Rating:	B (low risk level)

1. Addition of a Bypass Lane: A bypass lane may be considered for northbound right-turn traffic. A bypass lane will reduce the number of conflict points within the roundabout. It will also help to increase sight distance for northbound drivers entering the roundabout.

2. Staggered yield lines on three lane approaches: Staggered yield lines will improve intersection sight distance on the northbound approach to the roundabout. It will also decrease the chances of a heavy vehicle blocking the view of through traffic for a vehicle in the right lane.

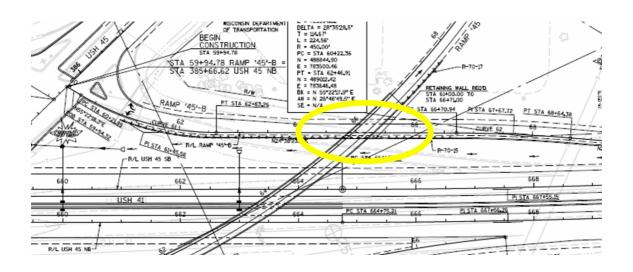
Southbound USH 45 off-ramp: Ramp F bridge may block visibility

The location of the bridge supports for Ramp F may block driver's sight distance for vehicles traveling on Ramp B. This will reduce decision sight distance and reaction time for drivers approaching the roundabout which is proposed for the intersection of this ramp and USH 45. As a result, this sight distance restriction may result in rear-end collisions.

Expected Crash Types:	rear end collisions
Expected Frequency:	occasional
Expected Severity:	low
Risk Rating:	B (low risk level)

Relocate the bridge support: It is suggested that relocating the bridge support further away from Ramp B to allow for enhanced sight distance of the roundabout. Enhanced sight distance will result in a additional reaction time and will therefore reduce the possibility of rear-end collisions occurring on this ramp

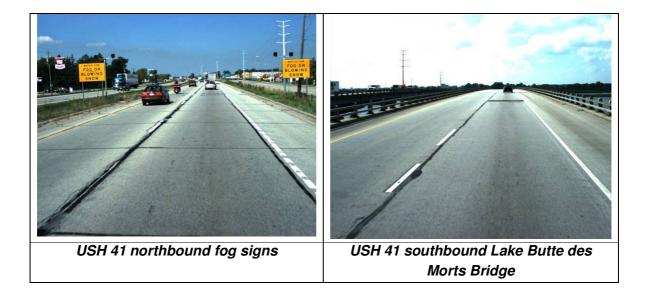
USH 41 is the only high-speed route across the Lake Butte des Morts/Fox River system near Oshkosh. The Lake Butte des Morts Bridge spans about 1,300 feet over the lake. The bridge is prone to poor weather conditions. Due to its location, the bridge is prone to snow drifts. In addition, drivers may fail to anticipate the frequent icy conditions on the bridge which regularly occur throughout the winter months. Visibility may be unexpectedly and intermittently reduced in foggy areas.

To address these weather related issues, FOG OR BLOWING SNOW warning signs have been provided on both the northbound and southbound approaches to the bridge. The beacons on these signs are activated manually by enforcement or maintenance personnel.

Expected Crash Types:	off road and fixed object collisions
Expected Frequency:	occasional
Expected Severity:	moderate
Risk Rating:	C (moderate risk level)

2. *Real-time road weather information system:* A real-time road weather information system will inform drivers of road conditions and advise drivers to slow down. The more drivers are informed the more cautious drivers will become of the icy and foggy conditions on the bridge. Cautious drivers will result in slower speeds, fewer injuries and fewer collisions.
