STH 16

IXONIA, WISCONSIN

ROAD SAFETY AUDIT

FINAL REPORT

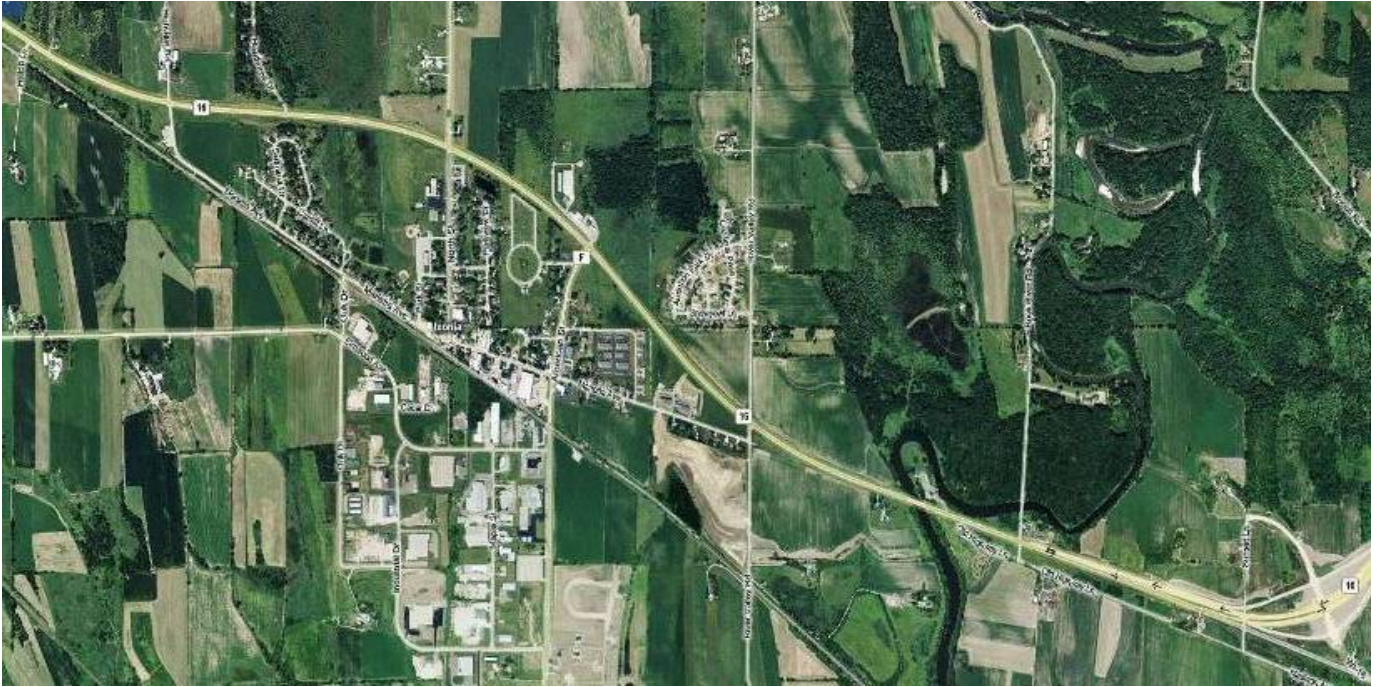
FIGURE 2 AERIAL PHOTO OF STUDY AREA

The study section of STH 16 is a two-lane undivided arterial with a rural cross section and roadside environment. FIGURE 2 presents an aerial map of the study area. The following seven unsignalized intersections along STH 16 were also reviewed as part of this study.

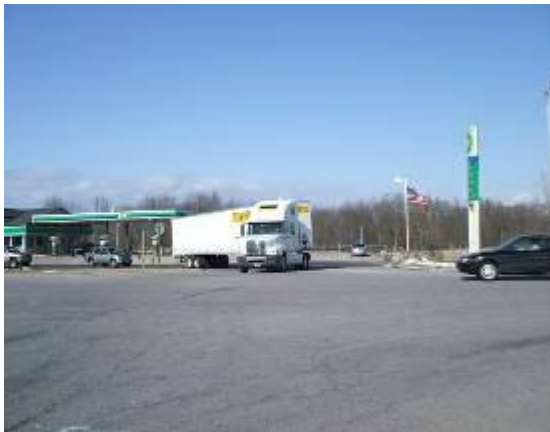
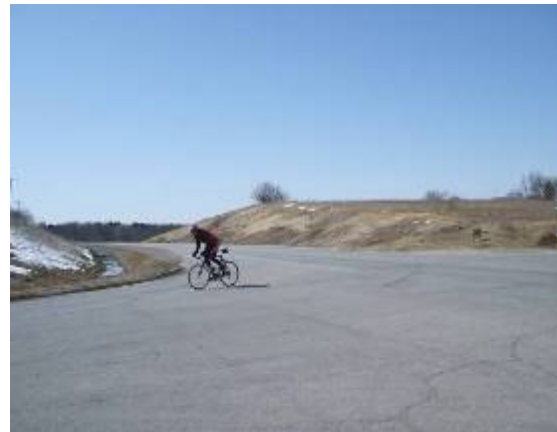
Road User Characteristics: STH 16 generally serves commuter, industrial and other local traffic. During site visits, traffic volumes were light during non-peak periods and moderate during commuter peak periods. Traffic patterns showed strong commuter trends with eastbound traffic heavier in the morning and westbound traffic heavier in the afternoon.

Different travel modes observed along STH 16

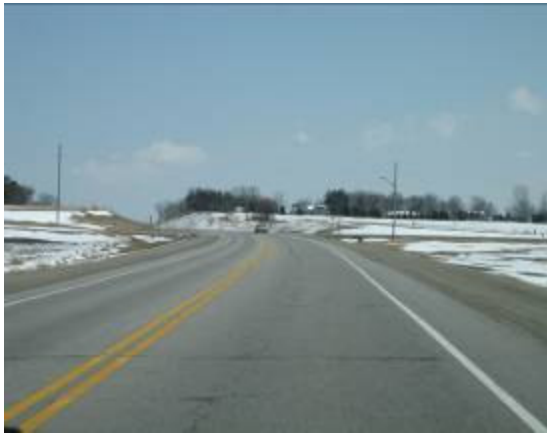
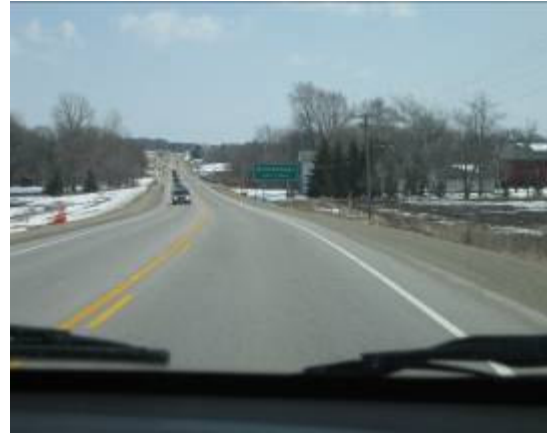
Road and Roadside Physical Characteristics: STH 16 is an undivided arterial with one through lane in each direction. The length of the corridor is approximately three miles. All intersections in the study area are unsignalized (stop-control for the side roads) “Type C” or “Type D” intersections. CTH F is a modified Type B intersection with bypass lanes. Three foot paved and seven foot unpaved shoulders are provided along STH 16. Pipe culverts and ditches are utilized for mainline drainage. Side roads intersecting STH 16 generally exhibit rural roadside characteristics with unpaved shoulders and open drainage. The Canadian Pacific railroad runs parallel to STH 16 through Ixonia (on the south side of mainline).

Two-lane rural cross section on STH 16

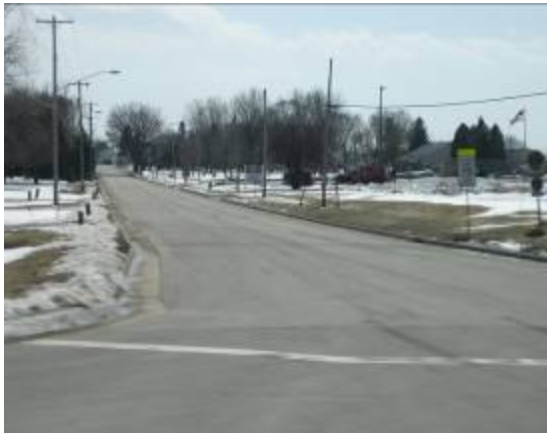
STH 16 and North Road intersection

Presence of high mounds near many of the intersections combined with horizontal curvature and skewed angles limit the sight distance to the intersections along the roadway.

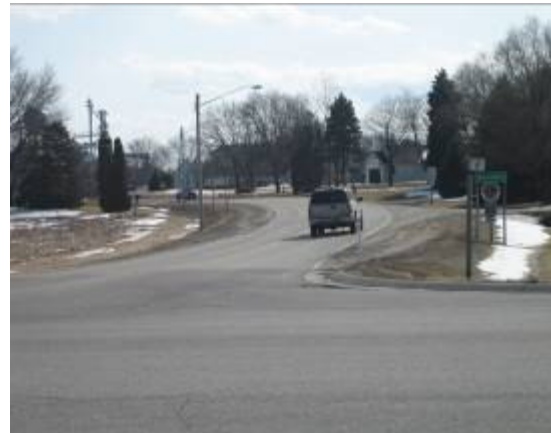
STH 16 and CTH F intersection

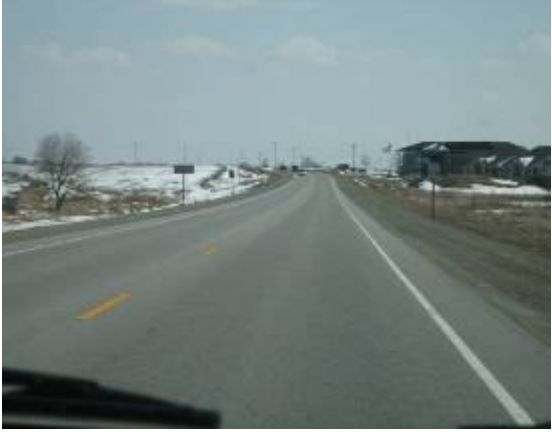
EXISTING SAFETY MEASURE	PHOTO
<p><i>Paved shoulders</i></p> <p>Three-foot paved shoulders (in addition to seven-foot aggregate shoulders) are provided along STH 16. Paved shoulders contribute to safety by a moderate reduction in crash frequency and a high reduction in crash severity due to the recovery room. Primarily, paved shoulders are beneficial to prevent run-of-road type crashes.</p>

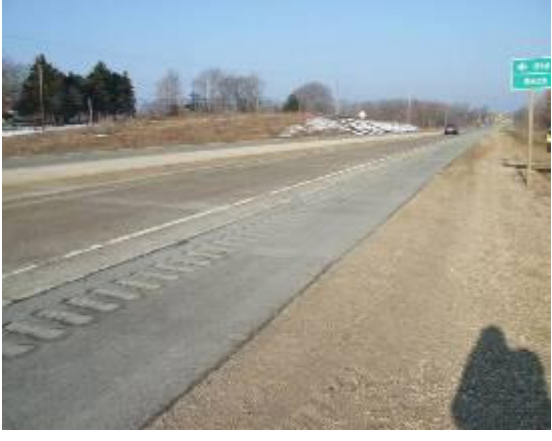
<p><i>Rumble strips</i></p> <p>Shoulder rumble strips are provided to the east of Rock River Road intersection, at the terminus of the Oconomowoc Bypass. Rumble strips add sound and vibration to the visual benefits of painted markings to alert drivers who have left the travel lane and entered the shoulder. Therefore, shoulder rumble strips reduce the likelihood of fixed object and run-off-road collisions.</p>

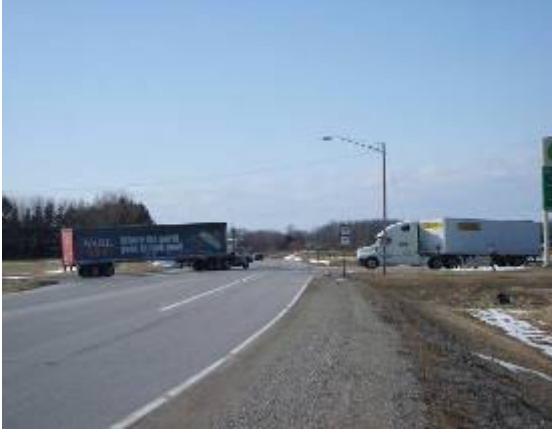
EXISTING SAFETY MEASURE	PHOTO
<p><i>Lighting</i> Lighting is provided at STH 16 and CTH F. All other intersections have light poles illuminating the side road approaches. Lighting improves intersection conspicuousness, so that approaching drivers are more aware of the intersection and the potential for conflicting movements. Lighting also improves the visibility of other road users, including pedestrians and bicyclists, at night.</p>

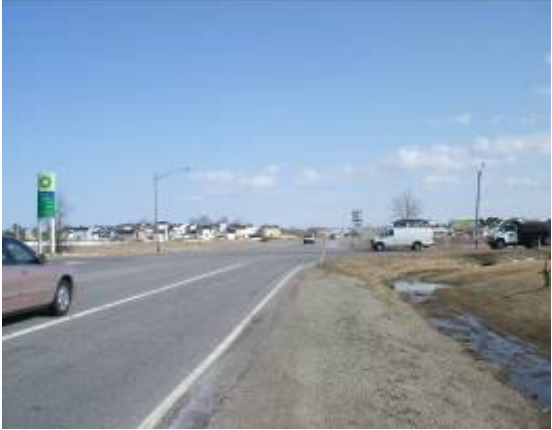
<p><i>Advance Street Name Signing</i> Advance street name signing is currently provided along STH 16 prior to CTH F and Rock River Road intersections. This signing provides additional guidance for unfamiliar and older drivers, and reduces the likelihood of sudden braking or evasive maneuvers near the intersection.</p>	 
<p><i>Pavement markings and delineation</i> Pavement markings and flexible delineators along STH 16 appear to be in good condition, providing adequate retro-reflectivity. This results in an increased guidance for drivers particularly during nighttime hours.</p>

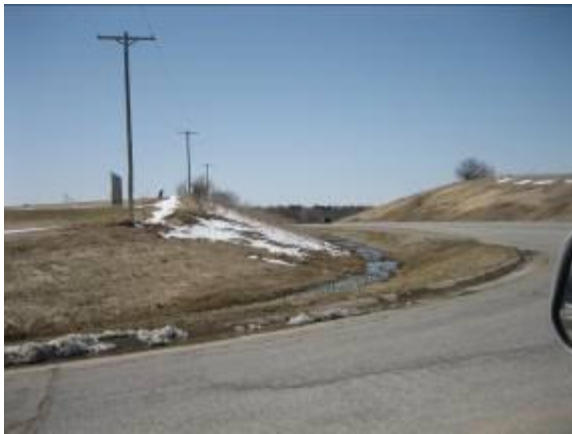
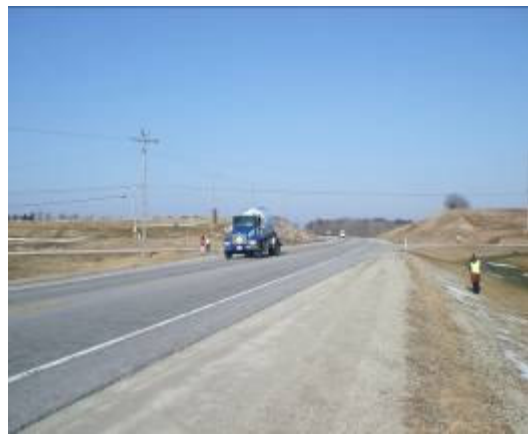
During the site visits, high embankments/mounds were observed on both sides of STH 16 approaching the intersections at River Valley Road, North Road, Hilltop Road and Hawthorn Drive. These intersections also happen to be located on curved segments of STH 16. Presence of mounds combined with horizontal curvature and intersection skew obstruct the visibility at the intersections. Drivers making turns from side streets onto STH 16 may be forced to pull further up onto the mainline in order to get a better vision angle. Due to this limited visibility of the intersections, drivers traveling on STH 16 may not fully perceive that they are approaching an intersection. These factors may contribute to the angle and sideswipe conflicts at the intersections.

Expected Crash Types: crossing and turning collisions, sideswipe collisions

Expected Frequency: occasional

Expected Severity: high moderate

Risk Rating: D (moderate-high risk level)

- Consider additional grading for mounds in order to increase intersection sight distance and visibility. At the intersection of North Road and STH 16 (by Ixonia Elementary School) a retaining wall could be installed if cross section is not wide enough to provide room for additional grading.
- Consider providing enhanced lighting at the intersections, especially over the mainline approaches.
- Provide advance street name signs at the River Valley Road and North Road intersections.
- Consider upgrading existing street name signs to current standards. Existing signs display 4" letters with no retro reflectivity. 6" - 8" minimum letters on reflective background is recommended. Signs with larger font will be more conspicuous and easier for approaching drivers to read.
- Consider mowing /clearing of excessive vegetation on the mounds beyond the 10' strip recommended per WisDOT policy.

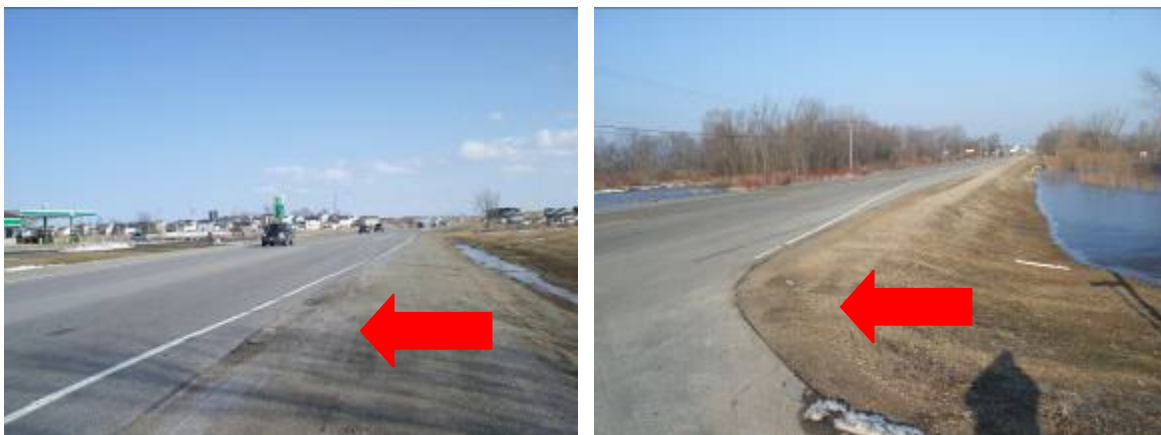
Lane departure crashes involving fixed-objects are the second most prevalent type of crashes reported in the study area between 2002 and 2006 (accounting for 28% of all crashes). Some examples include vehicles running into ditches, culverts, sign posts and bridge piers. There were also a notable number of head-on collisions (5 out of 57) that had occurred within the study area. During the site visits, it was observed that paved shoulders that are currently provided on the mainline do not continue through the taper portion of the roadway at the intersections. It was also noted that rumble strips that are provided along the Oconomowoc Bypass terminate at the Rock River Road intersection and do not continue through the study area.

Paved shoulders not carried through taper sections at the intersections

Expected Crash Types:	run-of-road crashes, head-on collisions, sideswipe (opposite direction) collisions
Expected Frequency:	occasional
Expected Severity:	high moderate
Risk Rating:	D (moderate-high risk level)

- Consider extending paved shoulders at the taper portions of STH 16 through the intersection areas.
- Consider extending shoulder rumble strips beyond the Rock River Road and River Valley Road intersections.
- Consider providing centerline rumble strips at the curved segments of STH 16 to prevent head-on crashes.
- Investigate opportunities for utilizing the “safety edge” as a shoulder treatment. The safety edge provides a bevel that cars can traverse, therefore helps errant vehicles to maintain stability, particularly on roadway re-entry.

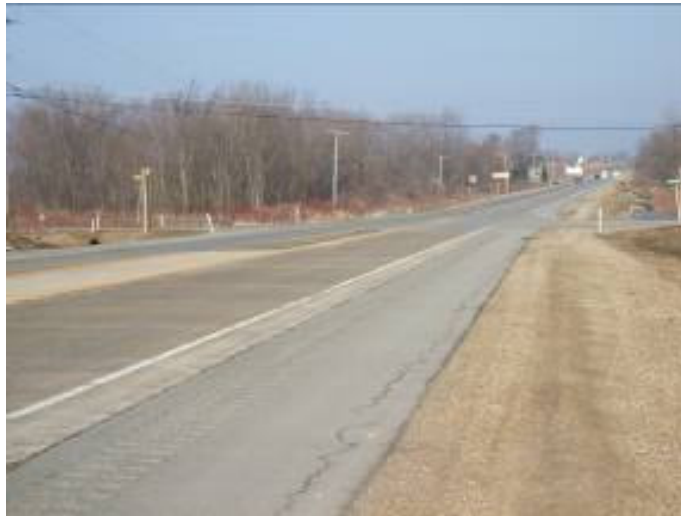
Rumble strips terminate to the east of Rock River Road intersection

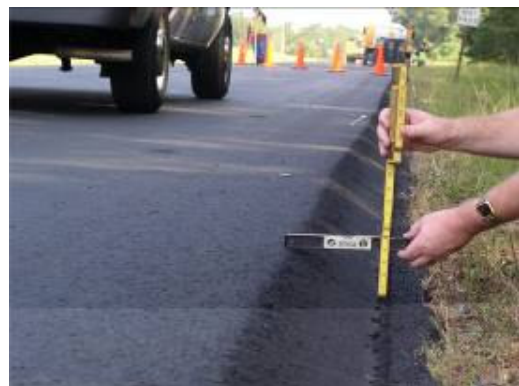
Safety edge

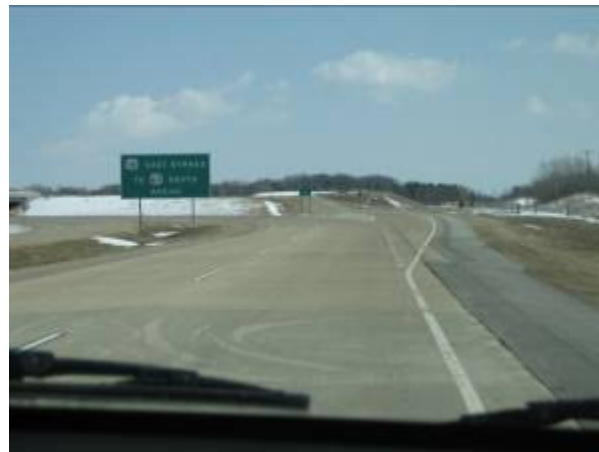
The Town of Ixonia is situated at the west end of the Oconomowoc Bypass, a four-lane divided highway with posted speed of 55 miles per hour. As noted in Section 1.5, posted speed limit on STH 16 remains at 55 miles per hour through the study area. During site visits, speeds of about 55 to 60 mph were observed on STH 16. Law enforcement officials indicated that drivers exceeding the speed limit on the Bypass most likely continue onto STH 16 without reducing their speed. Due to proximity to the high-speed facility and presence of unsignalized intersections reducing the posted speed on this segment of STH 16 is unlikely to reduce the prevailing speeds.

STH 16 at Oconomowoc Bypass

Expected Crash Types:	rear-end collisions, angle collisions
Expected Frequency:	occasional
Expected Severity:	moderate
Risk Rating:	C (moderate-low risk level)

- Opportunities for targeted speed enforcement could be considered.
- Consider installing permanent speed feedback signs for westbound STH 16 right after the Rock River Road intersection to capture drivers traveling with high speeds upon exiting the Oconomowoc Bypass.

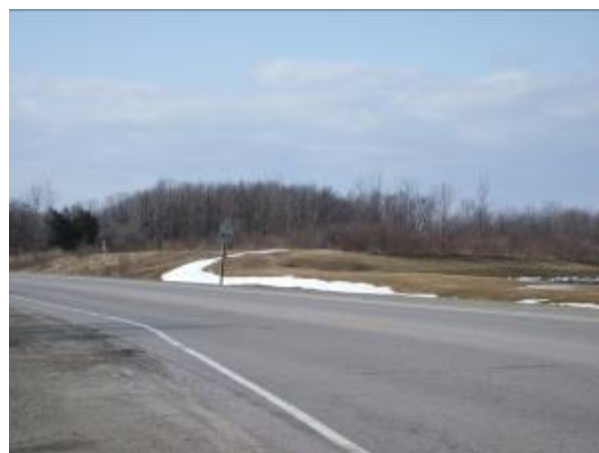
Posted speed is 55 mph on STH 16

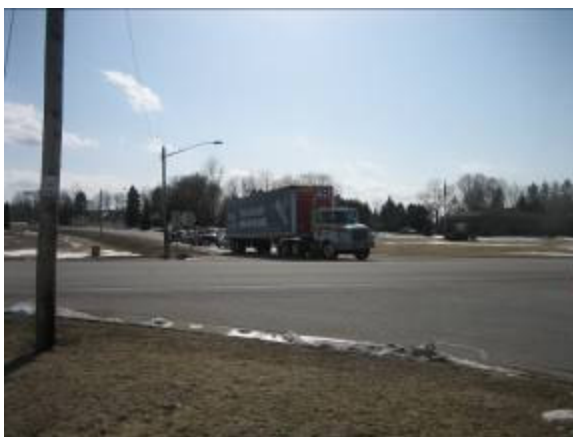
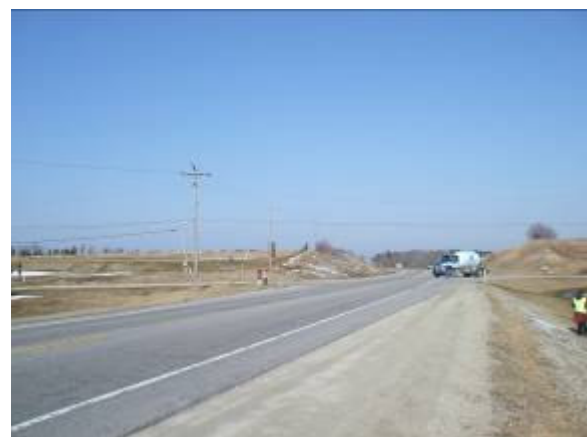
Vehicles approaching the intersections to make left turns may have limited sight visibility due to the intersection skew and high volumes of trucks. Due to limited visibility, drivers turning left may be braking when vehicles following are not expecting them to stop. Following vehicles, who are typically looking at the through traffic, may fail to see the vehicle in front stop suddenly, increasing the risk of rear-end conflicts. Drivers turning left may also be experiencing difficulty in judging the speed of oncoming vehicles, therefore choosing unsuitable gaps.

Expected Crash Types: rear-end collisions, angle collisions

Expected Frequency: occasional

Expected Severity: high moderate

Risk Rating: D (moderate-high risk level)

1. Consider providing exclusive left turn lanes (separated from through lane with striping or raised median) as well as channelized right turn lanes on STH 16. This would isolate the turning vehicles from the through lane and provide better visibility for the drivers. FIGURE 4 presents a schematic layout of the suggested improvement.

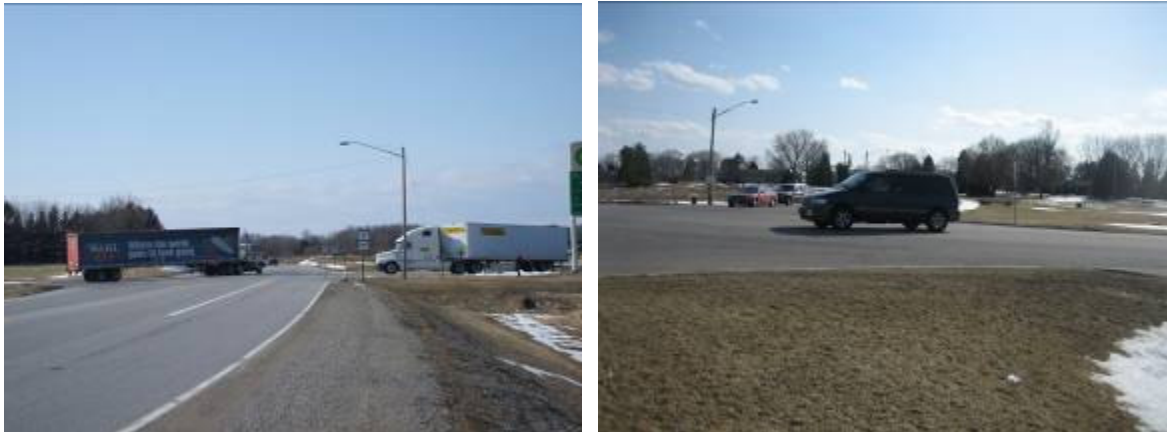
This issue specifically occurs at the intersection of STH 16 and CTH F, which displays the highest crash location on the study corridor. A schematic layout of STH 16 and CTH F is shown in FIGURE 3.

High volume of left turn movements observed at the intersection of STH 16 and CTH F

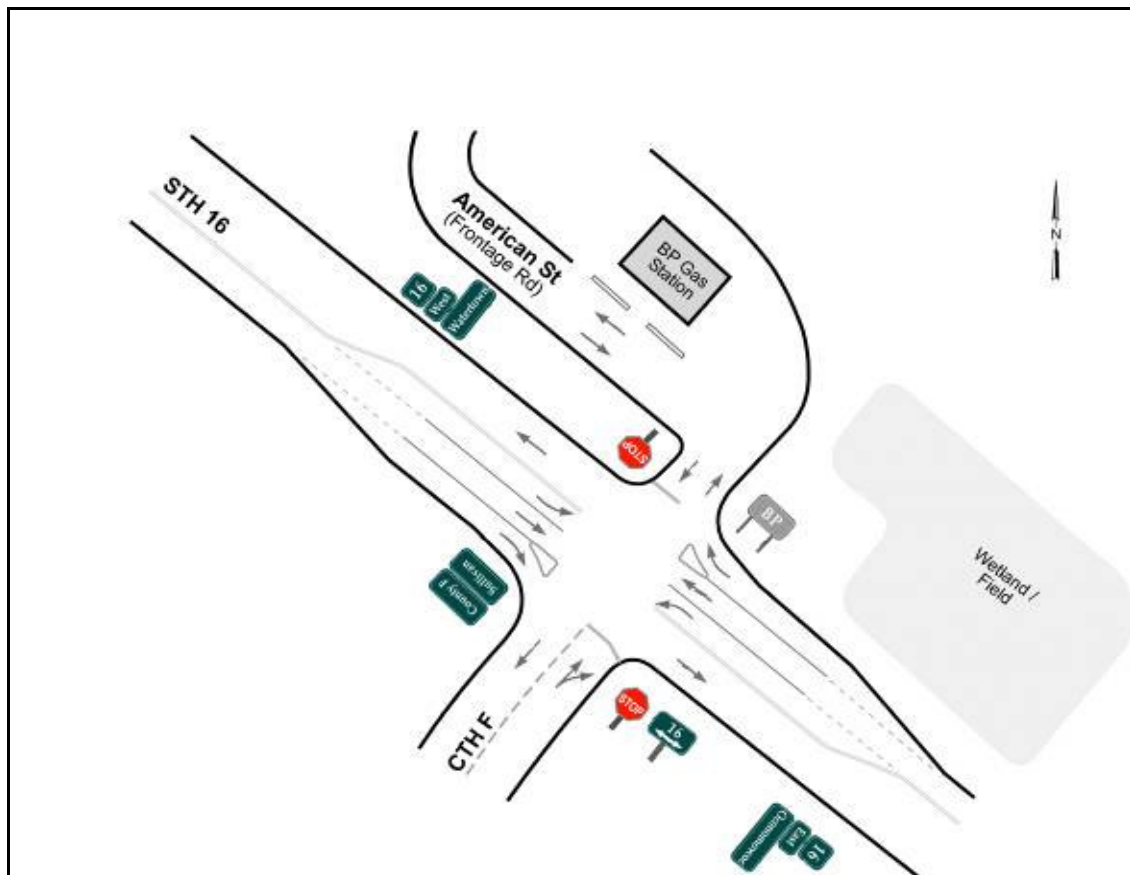
FIGURE 4 – Schematic layout for dedicated turn lanes at STH 16 and CTH F

Left-turn lanes remove vehicles waiting to turn left from the through-traffic stream, thus reducing the potential for rear-end collisions. Left turn lanes also provide a sheltered location for drivers to wait for a gap in opposing traffic, which may encourage drivers to be more selective in choosing a gap to complete the maneuver. This, in return, may reduce the potential for collisions between left-turn vehicles and opposing through vehicles. Right-turn lanes remove slow vehicles that are decelerating to turn right from the through-traffic stream, thus reducing the potential for rear-end collisions.

Estimated right-of-way impact of the suggested improvement would be minimal compared to the existing configuration of the intersection.

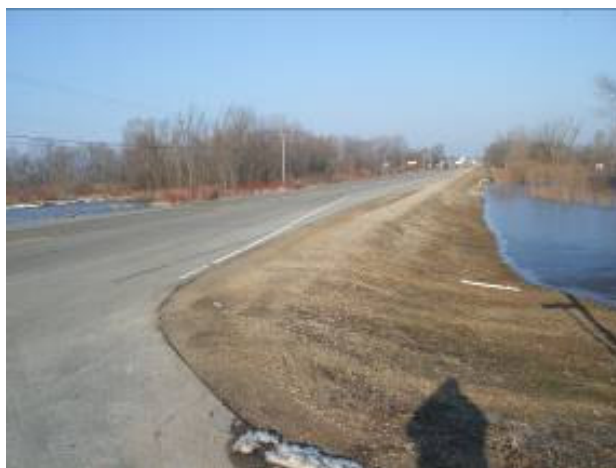
During the site visits, flooding near the ditches was observed along STH 16 from Oconomowoc Bypass to the River Valley Road intersection. This area is generally at a lower elevation compared to the roadway and can be characterized as marshland. Based on input received from town residents, foggy conditions are often observed near the banks of Rock River and adjacent Kanow Park.

Expected Crash Types:	run-of-road crashes, head-on collisions
Expected Frequency:	rare
Expected Severity:	high
Risk Rating:	C (moderate-low risk level)

- Consider extending shoulder rumble strips beyond the Rock River Road and River Valley Road intersections to prevent lane departure crashes involving vehicles running off the road and ending up in the flooded areas.
- Consider providing centerline rumble strips to prevent head-on crashes.
