**MOLE LAKE**

**ROAD SAFETY AUDIT**

Opus International Consultants Inc.

December 2008

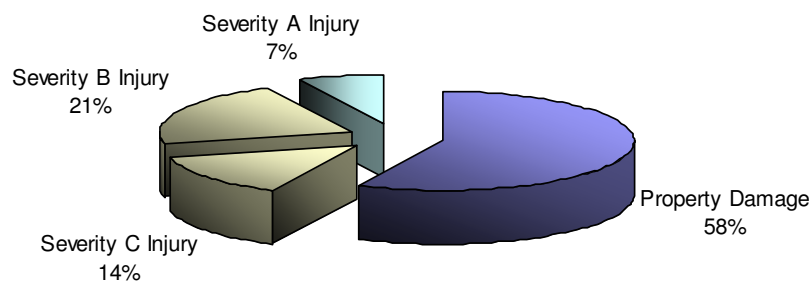
FIGURE 1.2 COLLISION SEVERITY DISTRIBUTION

Using collision data provided by the Wisconsin Department of Transportation, over a period of five years (2003 through 2007), a total of 14 collisions were reported within Mole Lake, excluding animal crashes. As summarized in FIGURE 1.2, 42 percent of the collisions resulted in at least one injury. The remainder of the collisions involved property damage only. No fatalities were reported during the study period.

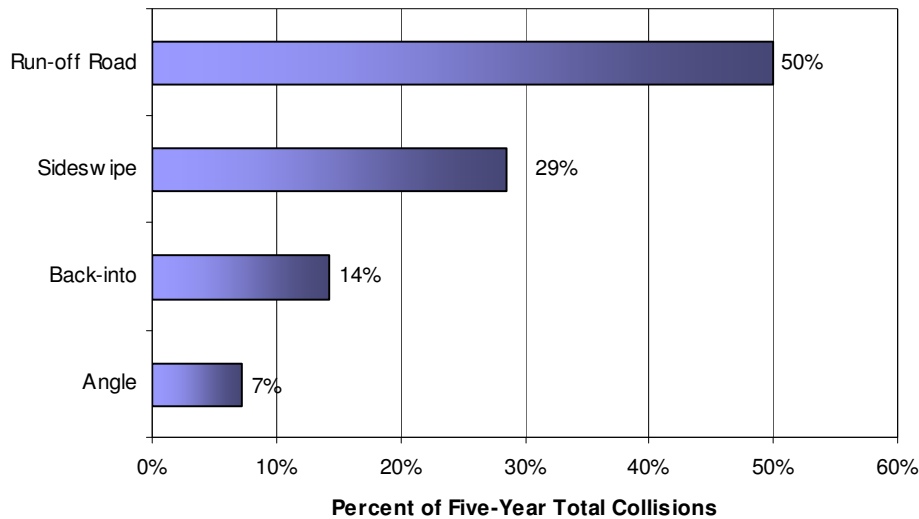
**FIGURE 1.3 COLLISION TYPES**

Collision type distributions are summarized in FIGURE 1.3. A review of the collision types shows that run-off road collisions and sideswipe collisions are predominant, representing 50% and 29% of the collisions respectively.

- Majority of collisions occurred on STH 55 and were run-off the road including overturn, ditch, and fixed object crashes.
- Three collisions occurred on STH 55 near Indian Settlement Road.
- A cluster of collisions occurred on STH 55 near CTH M and Mole Lake Rd, including run-off road and sideswipe collisions.
- A sideswipe collision involving a right-turning vehicle and a motorcycle occurred on STH 55 south of Sand Lake Road.
- 21 percent (3 crashes) were alcohol related.

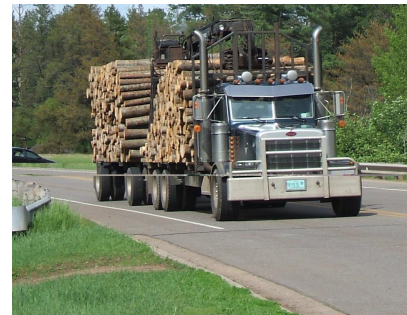
*Trucks* traveling through Mole Lake consisted of primarily logging trucks. Logging trucks are extremely large and heavy, contributing to long stopping distances and reaction times. This may be a potential hazard for non-motorized road users crossing STH 55 where sight distance is limited.

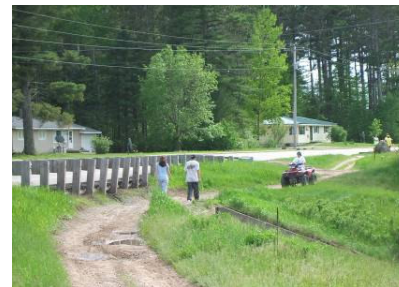
*All Terrain Vehicles (ATVs)/ Dirt Bikes*, reflecting use by:

- Traveling within Mole Lake
- Recreational use
- ATVs are prohibited on state and county highways but may be used on township roads only by ordinance and with DNR restrictions

ATVs are allowed to travel within the public right-of-way on township roads, but not on county roads and state trunk highways. During the RSA site visits, ATVs were observed traveling illegally on STH 55 (*above*).

Currently ATVs and dirt bikes utilize sidewalks and trails, which interact with pedestrians and recreational bike users. The sidewalks and trails are not wide enough to accommodate the different modes side-by-side. ATVs and dirt bikes are motorized vehicles which travel at a higher speed than pedestrians and bicyclists. This variance in speed between the modes increases the risk of a collision, resulting in severe injuries. The use of ATVs on trails can also lead to erosion, creating a hazardous walking facility for pedestrians and increasing the potential for damage to the shoulders and ditches.

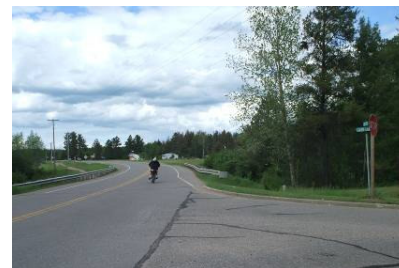
- STH 55 is a two-lane rural road and curb and gutter is present north of Mole Lake Road.
- An incomplete network of sidewalks and trails are provided within Mole Lake.
- Intersections with local roads are STOP controlled on the minor approach, and access to adjacent private properties is direct and uncontrolled.
- Posted speed limits are 35 mph between CTH M and Indian Settlement Road and 55 mph north outside of town.

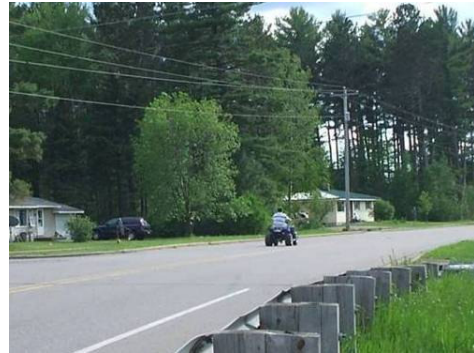
All terrain vehicles (ATVs) and dirt bikes have been a growing mode of travel and recreation within Mole Lake. It is an affordable method to travel short distances. ATVs do not have separate designated facilities to travel on; therefore, ATVs are forced to share the roadway with vehicles or interacting with non-motorized road users on the sidewalks and trails.

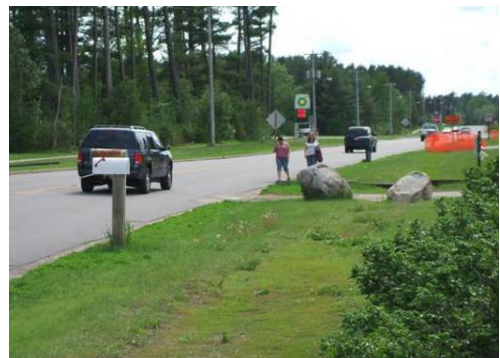
Large rocks have been distributed to residents in Mole Lake as a method to discourage ATVs from traveling on the front lawns of private homes. These large rocks may be considered to be potential fixed objects. The encroachment of the large rocks within the right-of-way and in some areas within the clear zone presents a hazard to vehicles that may have left the roadway, increasing the likelihood of severe fixed object collisions especially near driveways where there is a gap in the curb.

<b>Expected Crash Types:</b>	Fixed object crashes
<b>Expected Frequency:</b>	Infrequent
<b>Expected Severity:</b>	High
<b>Risk Rating:</b>	C (moderate risk level)

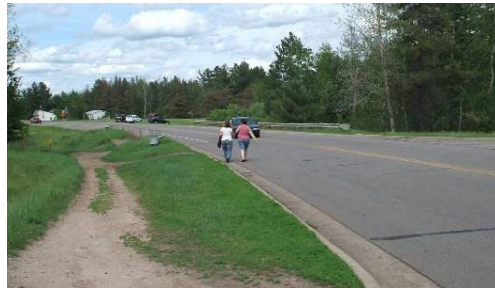
STH 55 runs north/south through the Mole Lake, providing the major north/south links in the area. Mole Lake residents were frequently observed walking along the highway and crossing STH 55. In several cases where sidewalks existed, pedestrians prefer to walk on the road. This may be due to the lack of a continuous network of sidewalks and maintenance. Pedestrians at highest risk include:

- Limited lighting conditions
- An absence of marked and signed pedestrian crossing facilities where drivers might not be able to anticipate pedestrians
- Areas without shoulders, where pedestrians must walk on the roadway

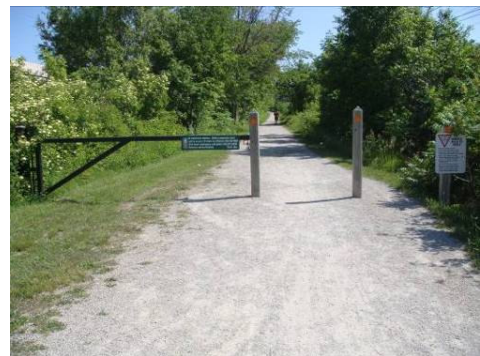
The tribe may also consider utilizing a system which may include bollards and/or gates at key locations along the sidewalks and trails accommodating pedestrians and bicyclists. An example of a system of bollards and gates is shown on the right. The spacing between the bollards must be wide enough to accommodate bicyclists, strollers and wheelchairs but narrow enough to prevent ATVs from accessing the sidewalk or trail. This system would ensure vehicles and ATVs remain off the sidewalks and non-motorized trails.

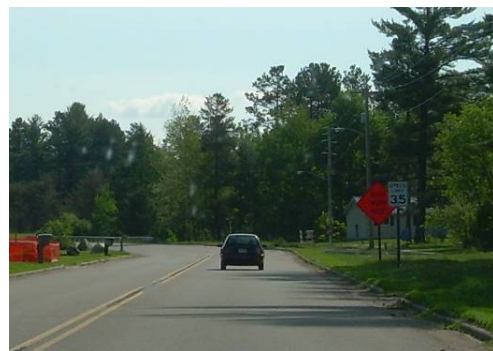
The speed limit increases from 35 mph to 55 mph north of Indian Settlement Road and south of CTH M. During the kick-off meeting it was reported that drivers were frequently observed traveling speeds of up to 55 mph through Mole Lake. During site visits, vehicles were observed traveling at higher speeds than the posted speed limit (35 mph) through Mole Lake.

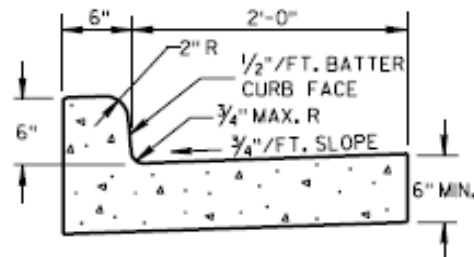
Between Sand Lake Road and Sokaogon Drive, the cross-section consists of 18 ft lanes including 30 in. Type D curb and gutter (*right*). North of Sand Lake Road and south of Sokaogon Drive, the cross-section consists of 15 ft lanes and 3 ft shoulders. The 18-foot wide lanes on STH 55 between Sand Lake Road and Sokaogon Drive are likely to contribute to speeding. The rural environment may also contribute to speeding. High operating speeds combined with the following factors increase the risk and the potential severity of collisions:

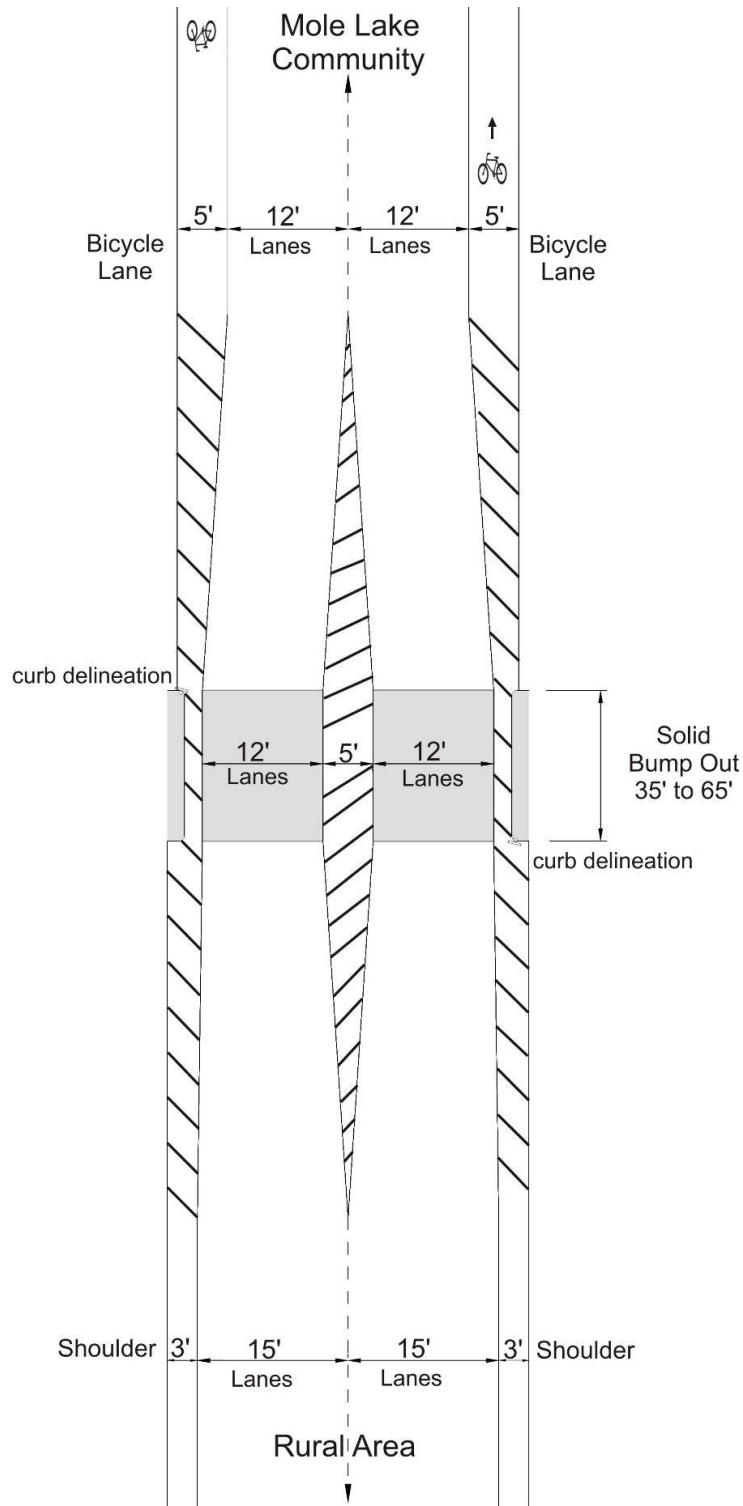
FIGURE 5.1 PROPOSED GATEWAY TREATMENT

A change in the road environment justifies a reduced speed limit. Drivers tend to travel based on the design speed of the roadway and not the posted speed limit. A gateway treatment may be implemented to inform drivers that they are transitioning from a rural environment into a more urban environment. A gateway treatment consists of measures that promote drivers' awareness that they are entering a more urban area where slower speeds are appropriate. Gateway treatments support, but do not replace, signing for a reduced speed limit.

Gateway treatments must be visible for approaching drivers to provide adequate stopping distance and must not limit sight distance from nearby access points. If sight distance permits, place the gateway treatment at a location where the urban land use is evident to drivers. Placing the speed reduction too far in advance of the community may reduce compliance (speed reduction is not justified to motorists), or motorists may slowly increase their speed by the time they reach the community.

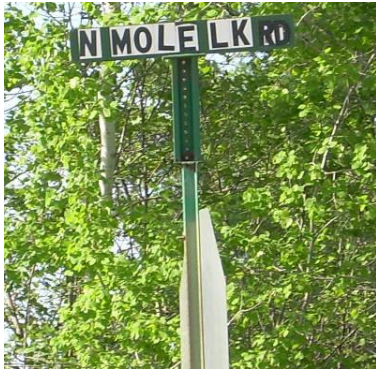
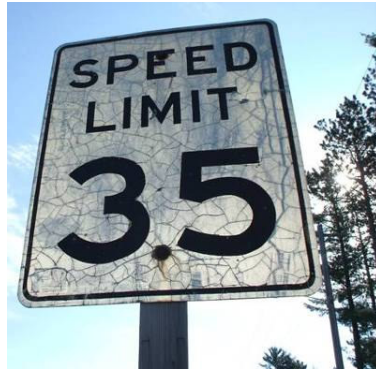
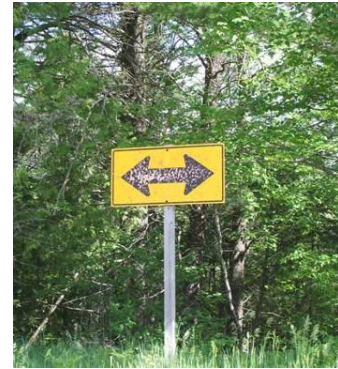
Signs provide warning and guidance to drivers concerning road alignment and conditions. During site visits, the RSA team observed signs that were worn or beyond its useful life, limiting retroreflectivity and conspicuity especially during nighttime hours. At these locations, driver guidance was limited by the following items:

- Cracked regulatory signs may not be visible at night therefore reducing driver compliance (*bottom center*),
- Faded or damaged warning signs may not provide adequate delineation and guidance (*bottom right*).

<b>Expected Crash Types:</b>	All crash types
<b>Expected Frequency:</b>	Occasional
<b>Expected Severity:</b>	Moderate
<b>Risk Rating:</b>	C (moderate risk level)

To improve night-time conspicuousness and visibility, and reduce long-term maintenance requirements, the use of higher retroreflective sheeting is now required. In December 2007 the FHWA began requiring that all transportation agencies implement a system of maintaining minimum retroreflectivity for signs. Engineering-grade sheeting (ASTM Type 1) needs to be replaced with more reflective sheeting which meets these new standards, such as high intensity (ASTM Type 3 or 4) or prismatic (ASTM Type 9 or Type 11) sheeting.

A comprehensive signing review should be undertaken throughout Mole Lake as a result of the new standards. It is suggested that a process which identifies and documents sign maintenance issues involving damaged signs, signs with poor retroreflectivity, or obsolete signs that should be removed be considered.

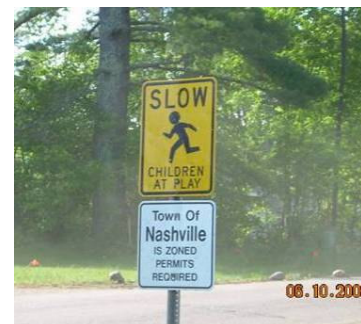
“Slow Children at Play” signs (*below left*) are posted in areas where pedestrians, particularly children, may be crossing the road. These signs are not consistent with current signs posted throughout the state and nation. This sign may also pose as a hazard for children by encouraging children to play in the road. It has been found in other areas that this sign message creates a false sense of security for children as they assume drivers know

that they are in the road may not find it necessary to clear oncoming traffic.

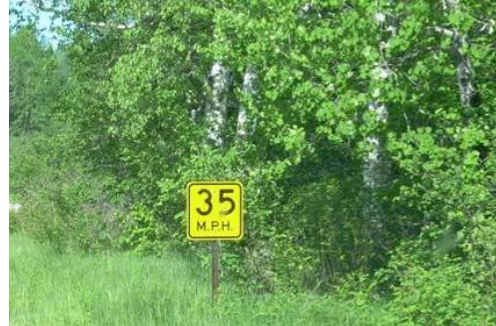
Yellow advisory speed plaques (*below right*) were posted throughout Mole Lake in lieu of standard speed limit signs. The MUTCD<sup>7</sup> states that supplemental plaques shall not be mounted alone or displayed alone, and shall be installed on the same post as a warning sign. Signs not in compliance with MUTCD standards may confuse or misinform drivers.

<b>Expected Crash Types:</b>	All crash types
<b>Expected Frequency:</b>	Occasional
<b>Expected Severity:</b>	Moderate
<b>Risk Rating:</b>	C (moderate risk level)

The advisory speed plaques should be replaced with standard regulatory speed limit signs (R2-1) to remain consistent with standards. The proper speed limit signs would effectively inform drivers of the speed limit.

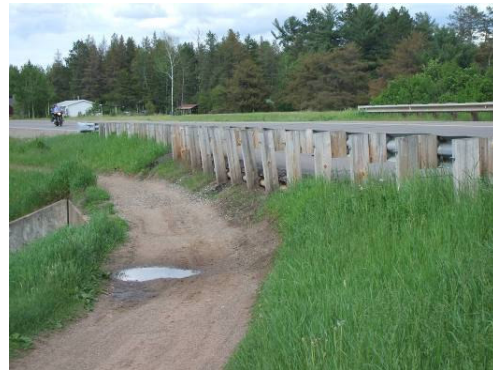
An unofficial trail adjacent to the bridge over Swamp Creek is extremely close to the box culvert. The box culvert is unshielded and is seen as a hazard for ATV's and pedestrians utilizing the trail. A risk is associated with pedestrians, bicyclists, ATVs or dirt bikes falling into the shallow creek, resulting in a severe injury.

**Expected Crash Types:** ATV and pedestrian crashes

The existing trail should be considered for closure due to the hazards associated with the adjacent box culvert and erosion of the bridge. Separate facilities should be considered to accommodate pedestrians and ATVs. If trail remains open, a barrier should be implemented to protect anyone from falling into the shallow creek.

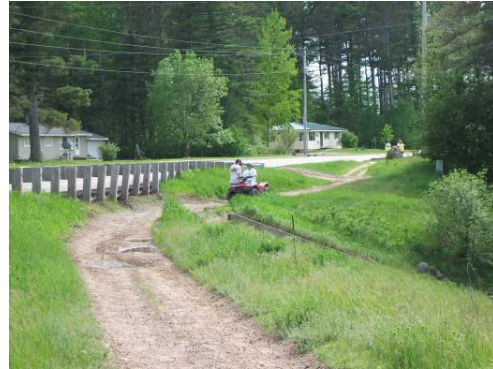
ATVs, pedestrians and bicyclists utilize the trail adjacent to the Bridge over Swamp Creek. The trail is not wide enough to comfortably accommodate the different modes. During the site visits, frequent interactions between ATVs and pedestrians were observed. This increases the risk of a collision between an ATV and a pedestrian or someone falling into the shallow creek. Also, ATVs utilizing the trail contributed to erosion, creating a hazardous walking facility for pedestrians and damage to the bridge structure.

<b>Expected Crash Types:</b>	ATV and pedestrian crashes
<b>Expected Frequency:</b>	Infrequent
<b>Expected Severity:</b>	High
<b>Risk Rating:</b>	C (moderate risk level)

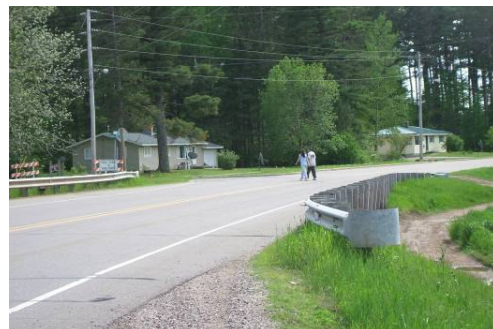
Intersection conspicuity at Sand Lake Road is limited by the presence of a horizontal curve. A high volume of pedestrians and ATVs were observed crossing at the south end of the bridge over the Swamp Creek to get to Sand Lake Road and the sidewalk on the south side of the intersection. Visibility of crossing pedestrians is further limited by the guardrail and the slope approach to the unmarked crossing on the west

side of STH 55. No pedestrian warning signs are provided on the approaches. Drivers may not realize that a pedestrian, bicycle or ATV is within the roadway due to these sight distance restrictions, resulting in inadequate reaction time.

A bicycle fatality was reported when a bicyclist was struck by a southbound vehicle while crossing STH 55 at Sand Lake Road, approximately six years ago. The RSA team understands that this crash may have occurred as a result of limited sight distance due to the sloped trail which is obscured by the guardrail.

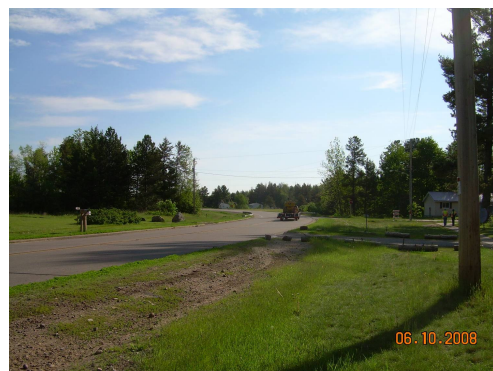
Drivers approaching Sand Lake Road on STH 55 have a limited view of the intersection due to the horizontal curve. Sand Lake Road is expected to attract significant numbers of unfamiliar drivers in the future looking to access the proposed ATV campground which will result in higher traffic volumes. Unfamiliar drivers may not expect the Sand Lake Road in advance of the intersection due to the lack of advance signing, resulting in sudden braking or unsafe u-turns.

Restricted sight visibility may also be an issue for drivers who may not expect vehicles ahead to slow down to turn onto Sand Lake Road, or vehicles to turn off of Sand Lake Road in front of them.

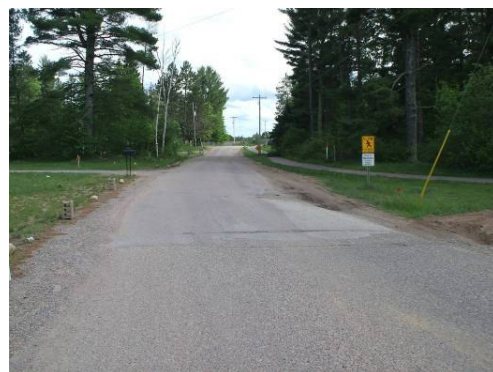
Sand Lake Road is a primary connection between STH 55 and CTH W. It is also the main access point for the tribal offices and the future ATV campground. During site visits a high volume of logging trucks and dump trucks were observed utilizing the roadway. The existing pavement condition is also deteriorating, affecting driver control and load stability.

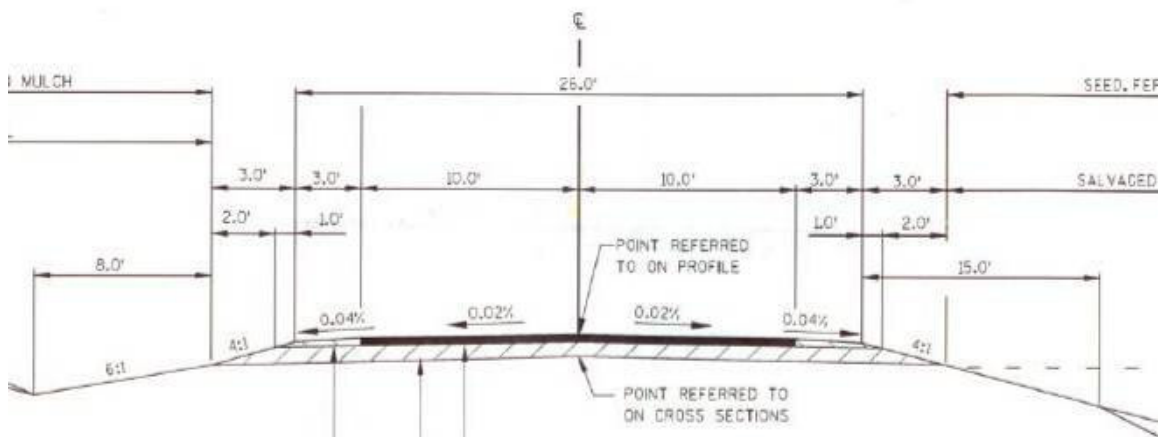
The proposed ATV campground will attract significant amounts of large vehicles such as RVs. To accommodate these large vehicles and the future traffic growth, Sand Lake Road is scheduled to be reconstructed. The proposed design of the roadway incorporates 10 ft lanes, however it has been indicated that the design has been changed to 12 ft lanes. Ten foot lanes may not comfortably accommodate two large vehicles side-by-side.

<b>Expected Crash Types:</b>	Sideswipe-opposite collisions
<b>Expected Frequency:</b>	Occasional
<b>Expected Severity:</b>	Low
<b>Risk Rating:</b>	B (low crash risk)

Twelve foot lanes are recommended on Sand Lake Road to accommodate the future traffic growth of large vehicles. The *Geometric Design of Highway and Streets*<sup>9</sup> states that 12 foot wide lanes provide desirable clearance between large vehicles on two-lane two-way rural highways where large vehicles are expected. It is recommended that the tribe confirm that the lane widths in the designs have been updated to 12 foot lanes.

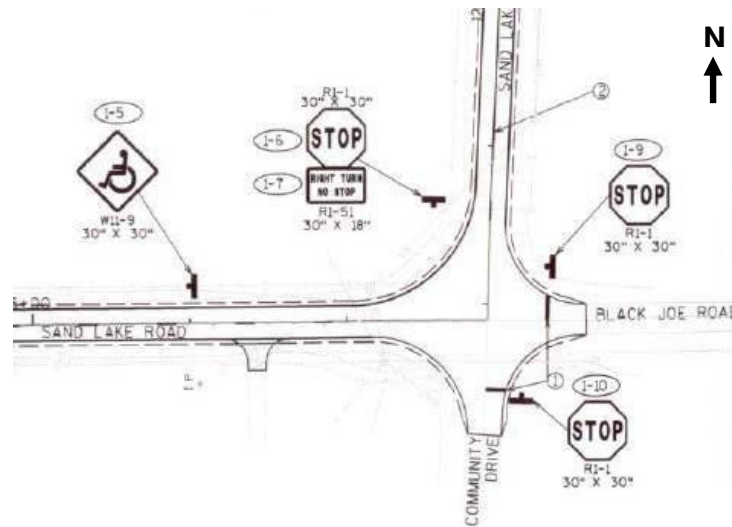
The intersection of Sand Lake Road/Black Joe Road/Community Drive is also included within the planned reconstruction. The intersection is proposed to accommodate traffic continuing on Sand Lake Road as a free-flow movement. Community Drive and Black Joe Road are STOP controlled. The westbound approach on Sand Lake Road is also STOP controlled except for the right-turn movements continuing on Sand Lake Road. A sign proposed underneath the STOP sign states, "Right Turn No Stop".

The proposed intersection control is not intuitive. Drivers waiting at the STOP control may not realize southbound Sand Lake Road is uncontrolled. Westbound right-turn movements from Sand Lake Road may also be an issue. Drivers may perceive that the right-turn vehicle is slowing down to Stop, where instead the vehicle is slowing down to turn right onto northbound Sand Lake Road. The proposed intersection control may increase the number of conflicts and the likelihood of a collision to occur.
