**INTERSECTION SAFETY
AUDIT: STH 16/67 AND
CTH Z**

OCONOMOWOC, WI

July 2008

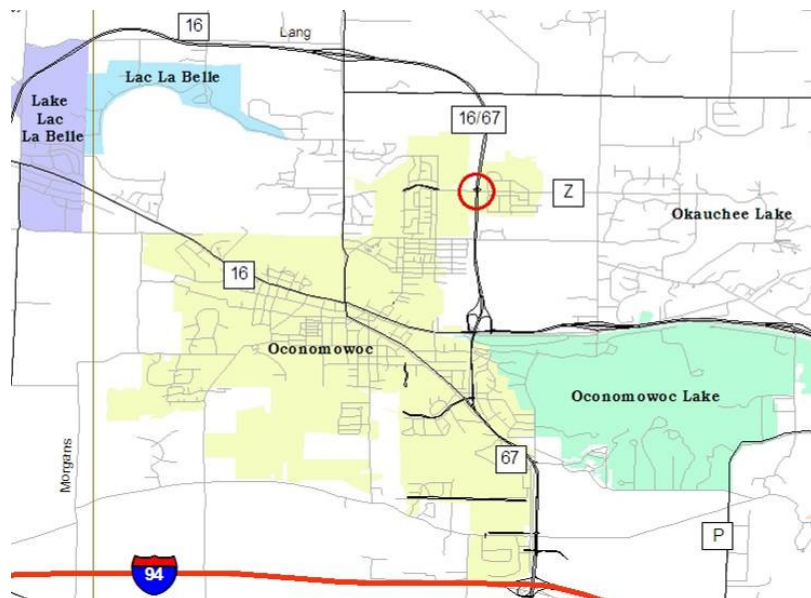
FIGURE 1.1 STUDY INTERSECTION

The intersection of STH 16/67 and CTH Z is a four-legged intersection located on the western edge of the Milwaukee metropolitan area in Waukesha County. The intersection is located on the northeast side of Oconomowoc on the Oconomowoc Bypass. North of the intersection, the Oconomowoc Bypass is fully access controlled with no at-grade intersections. The land use near the study intersection is a mix between residential, academic and rural and is rapidly changing. The study intersection is shown in FIGURE 1.1.

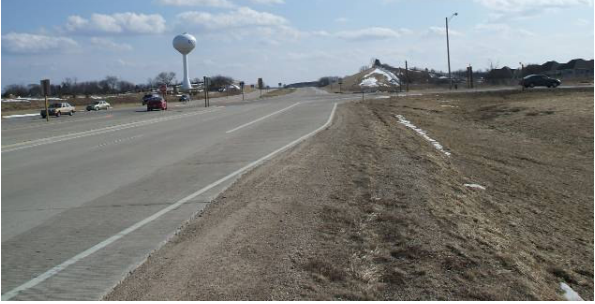
<p style="text-align: center;"><i>Looking Southbound</i></p>
Non-Motorized Facilities	None	East Leg: sidewalks on both sides end before STH 16/67 West Leg: sidewalk on the south side of CTH Z ends before STH 16/67

CHARACTERISTIC	STH 16/67	CTH Z	PHOTO
Vertical Alignment	Slight gradient on the northbound approach	Level

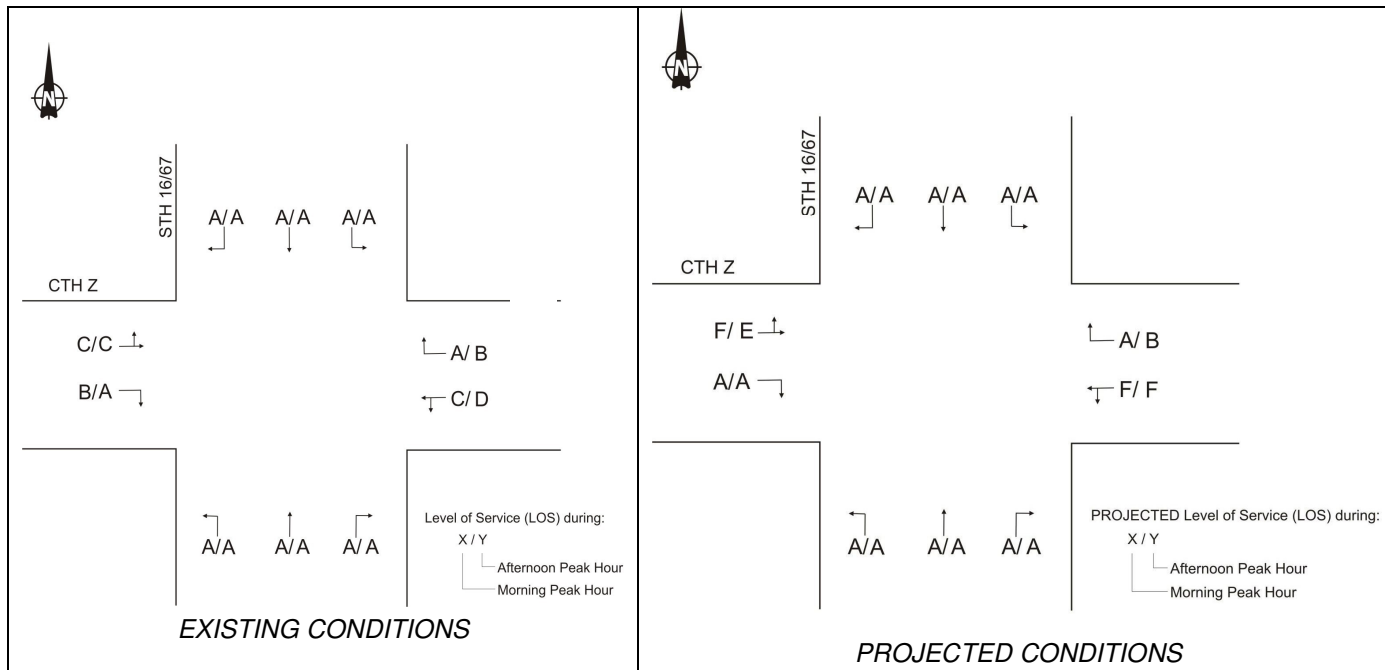
FIGURE 3.2 TRAFFIC OPERATIONS ANALYSIS

A traffic operational analysis was performed to analyze the existing conditions using Synchro. The existing and proposed levels of service (LOS) are illustrated in FIGURE 3.2 for both morning and afternoon peak periods. Synchro output reports are provided in APPENDIX B. As can be seen in FIGURE 3.2, traffic on STH 16/67 currently operates at a LOS A for both the morning and afternoon peak hours. The westbound through/left turn movements currently operate at a LOS D during the afternoon peak hour.

If no change to the intersection traffic control are implemented after the school and YMCA open, the LOS for eastbound through/left is expected to decrease from C to F in the morning and C to E in the afternoon. The westbound through/left movement is expected to decrease from a LOS C to F in the morning. The westbound through/left movement is expected to decrease from LOS D to F in the afternoon. No significant additional delay is expected on STH 16/67.

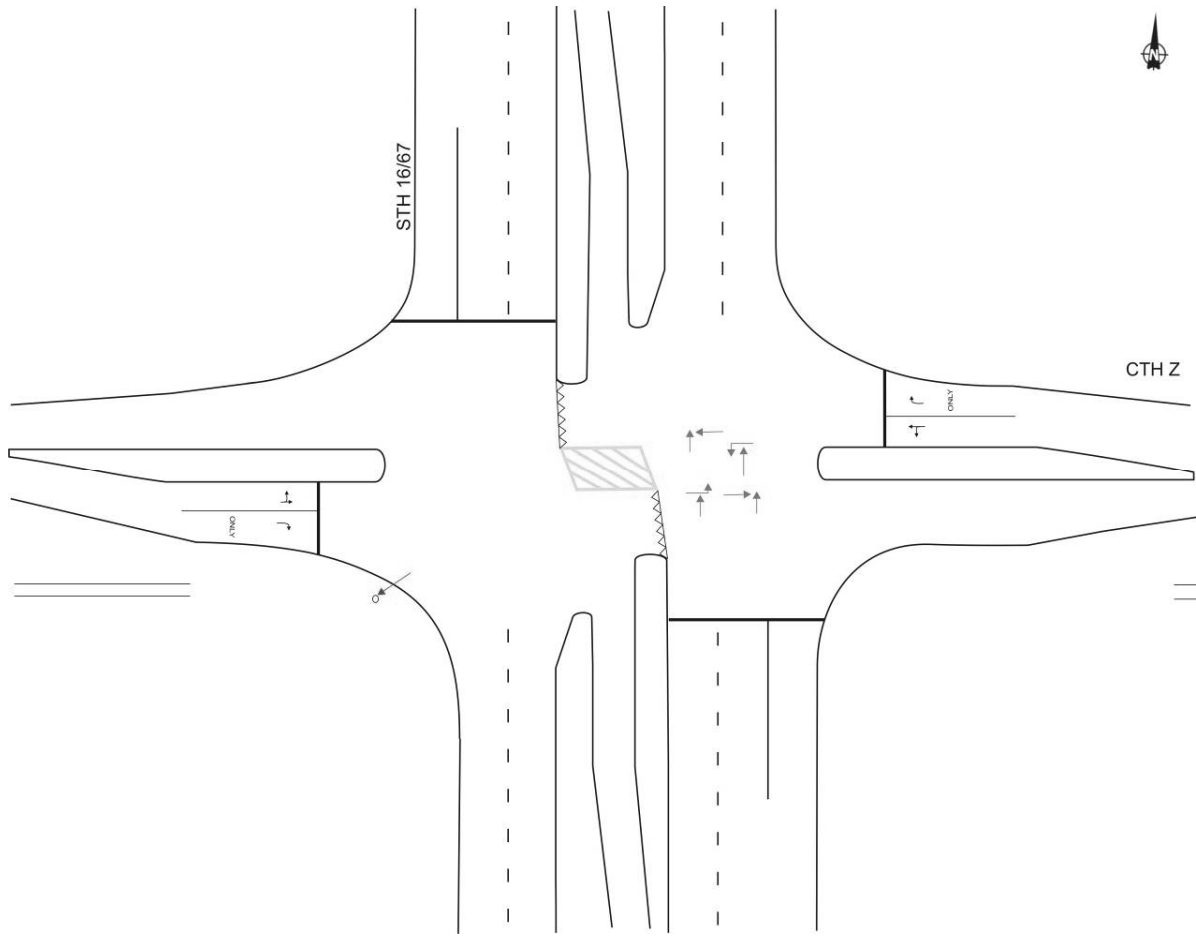
FIGURE 4.1 COLLISION DIAGRAM

Police collision reports (MV4000) for 2005 through 2007 were reviewed as part of this study. Over these three-years, five collisions were recorded at or near the intersection. As summarized in TABLE 4.1, one fatality and one injury occurred at the intersection. The remainder of the collisions involved property damage only.

A collision diagram illustrating the spatial distribution of the collisions is shown in FIGURE 4.1.

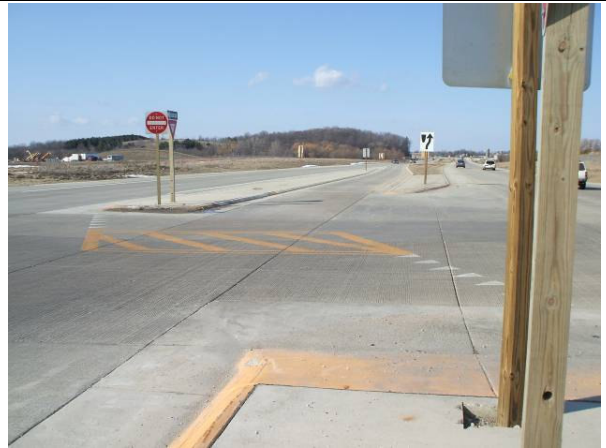
Left-turn lane on northbound STH 16/67

Slotted positively offset left-turn lanes have been provided for drivers on STH 16/67 at CTH Z. The positively offset left-turn lanes provide enhanced sight distance of oncoming traffic by locating the left-turn lane to the left of the opposing left-turn lane. This eliminates any blocking of the oncoming through traffic by the opposing left-turn lanes.

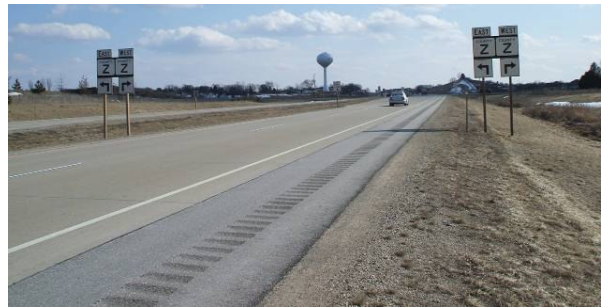
Advanced street signing is currently provided for on all of the intersection's approaches. These signs provide additional guidance for unfamiliar and older drivers. The advanced street signing helps drivers locate lanes they need to be in prior to the intersection, reducing lane changes close to the intersection. The oversized signing on STH 16/67 approaches provides enhanced guidance to approaching drivers on these high speed approaches.

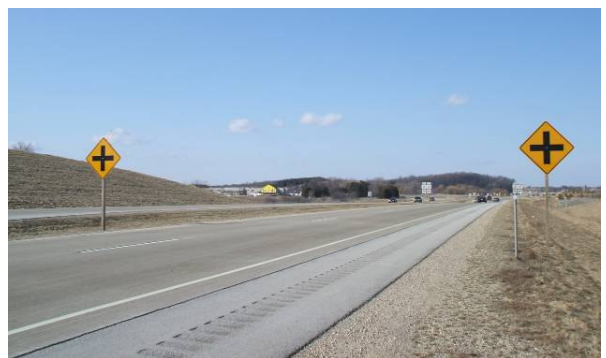
STH 16 is a fully access controlled roadway between IH-94 and the Jefferson County line other than this short section. The intersection warning signs on STH 16/67 help to inform drivers they are approaching an at-grade intersection which is inconsistent with the rest of the corridor. Research by the Missouri DOT has found the use of intersection warning signs to reduce crashes by 40%.

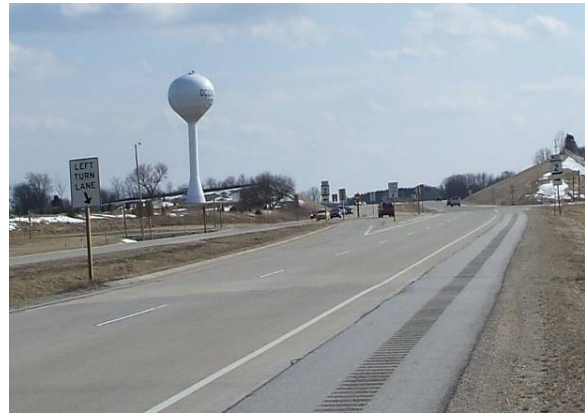
Shoulder rumble strips are widely used on freeways and expressways throughout Wisconsin. The use of shoulder rumble strips on STH 16/67 reduces the risk of run-off-road single vehicle run-off-road crashes.

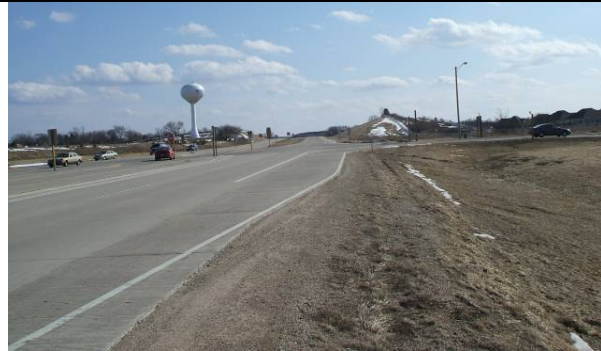
Lighting has been provided at the intersection of STH 16/67 and CTH Z. Lighting improves intersection conspicuousness, so that approaching drivers are more aware of the intersection and the potential for conflicting movements. Lighting also improves the visibility of other road users, including pedestrians and bicyclists, at night.

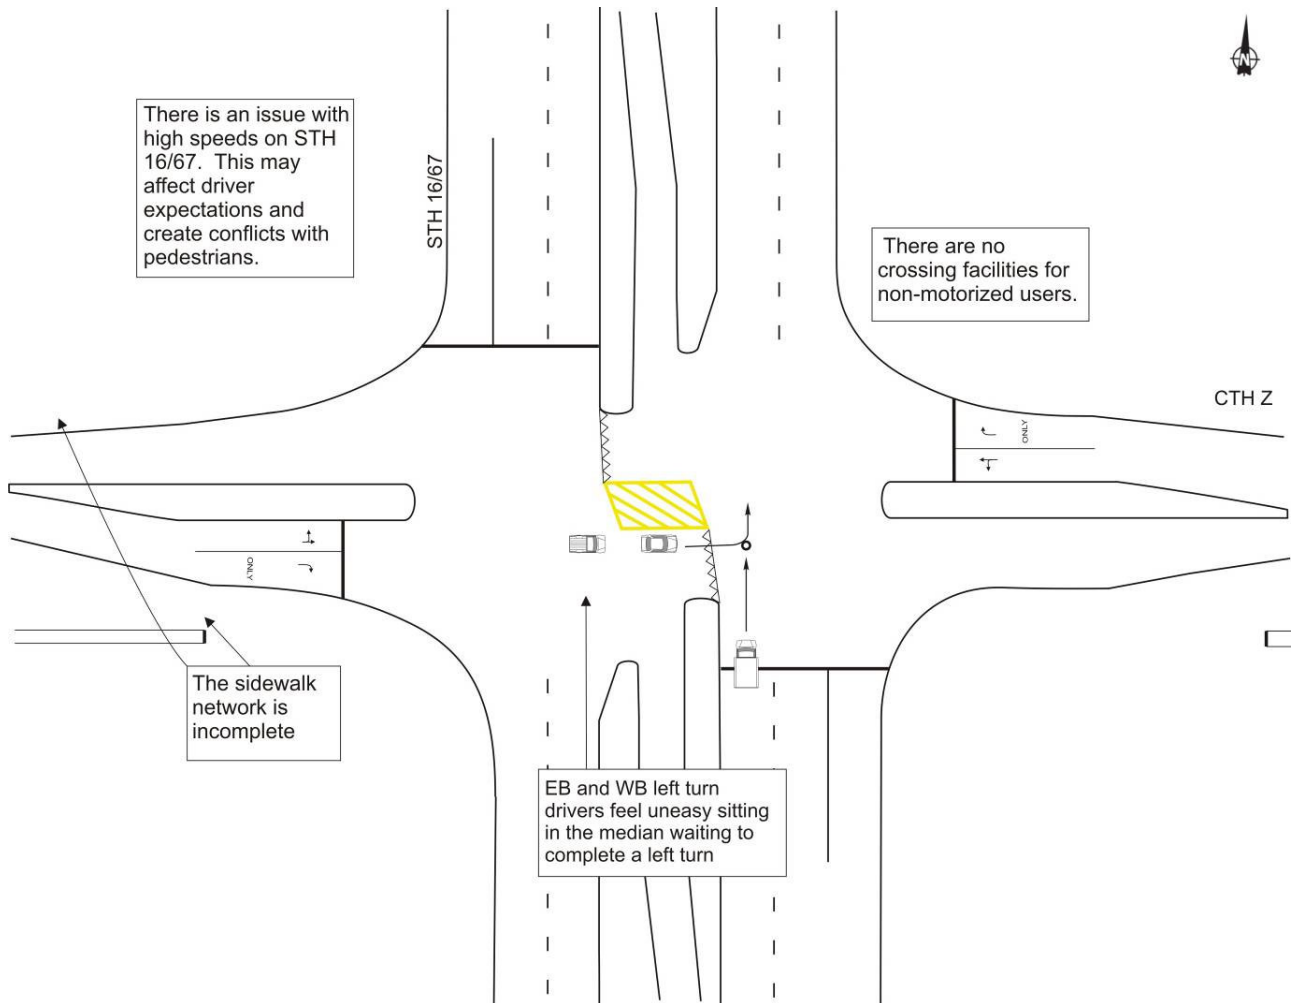
FIGURE 6.1 SAFETY ISSUES

On the basis of the reviews summarized in Sections 2 through 4, issues affecting traffic safety have been identified. These issues are summarized in FIGURE 5.1 and discussed below. Mitigation measures are discussed in Section 6.

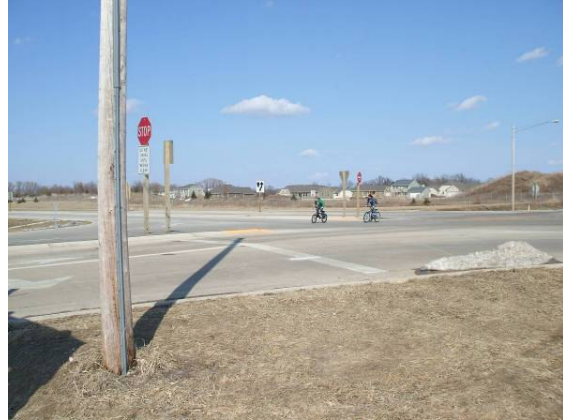
11 and 14 years old. There are currently no pedestrian or bicycle facilities at this intersection as it was part along a high-speed bypass. The existing sidewalks adjacent to CTH Z terminate prior to the intersection.

Younger pedestrians are typically more inexperienced and have a high propensity to take risks. These inexperienced pedestrians may choose inadequate gaps as they are not as good at judging approach speeds. In addition, as is shown in the photo on the right, younger road users also will make risky maneuvers as a means to “show off.”

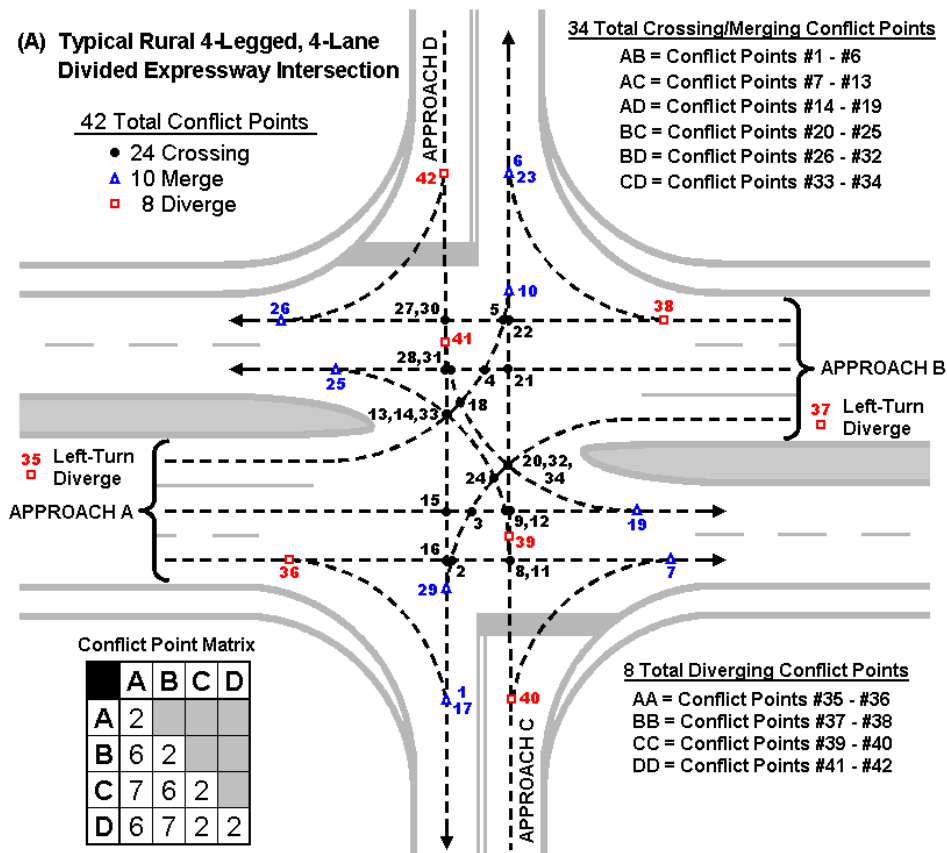
FIGURE 6.2 INTERSECTION CONFLICT POINTS¹

There are multiple conflict points associated with making a direct left-turns onto STH 16/67 from CTH Z. This intersection involves an unprotected left-turn across multiple lanes of opposing or crossing traffic. The risk and potential severity of left-turn crashes is aggravated by:

FIGURE 6.1 illustrates a conflict diagram for the typical four-leg the intersection. A total of 42 conflict points exist for this type of intersection configuration. Drivers who misjudge the gaps required to turn left or cross increase the risk of a higher severity rear-end or angle crash with through vehicles traveling at high speeds.

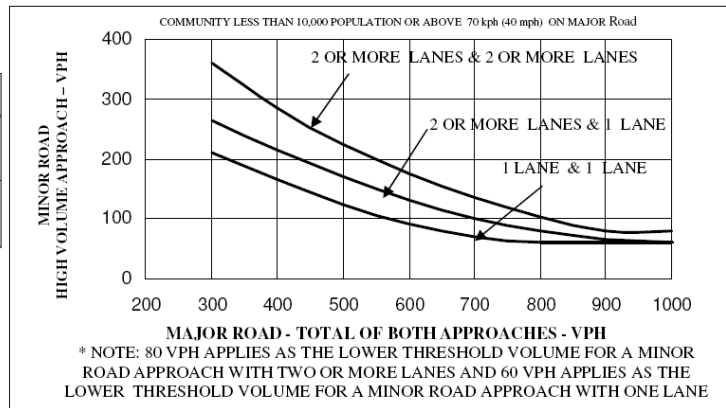
Figure A. Criteria for “70%” volume level.

Plot four volume combinations on the applicable figure below. If four points lie above the appropriate line, then the warrant is satisfied.

Hour	4	5	7	6
Major Vol.	886	876	757	694
Minor Vol.	122	114	140	123

Satisfied?: **YES**
