Pedestrian & Bicyclist Accommodation Design for Work Zones

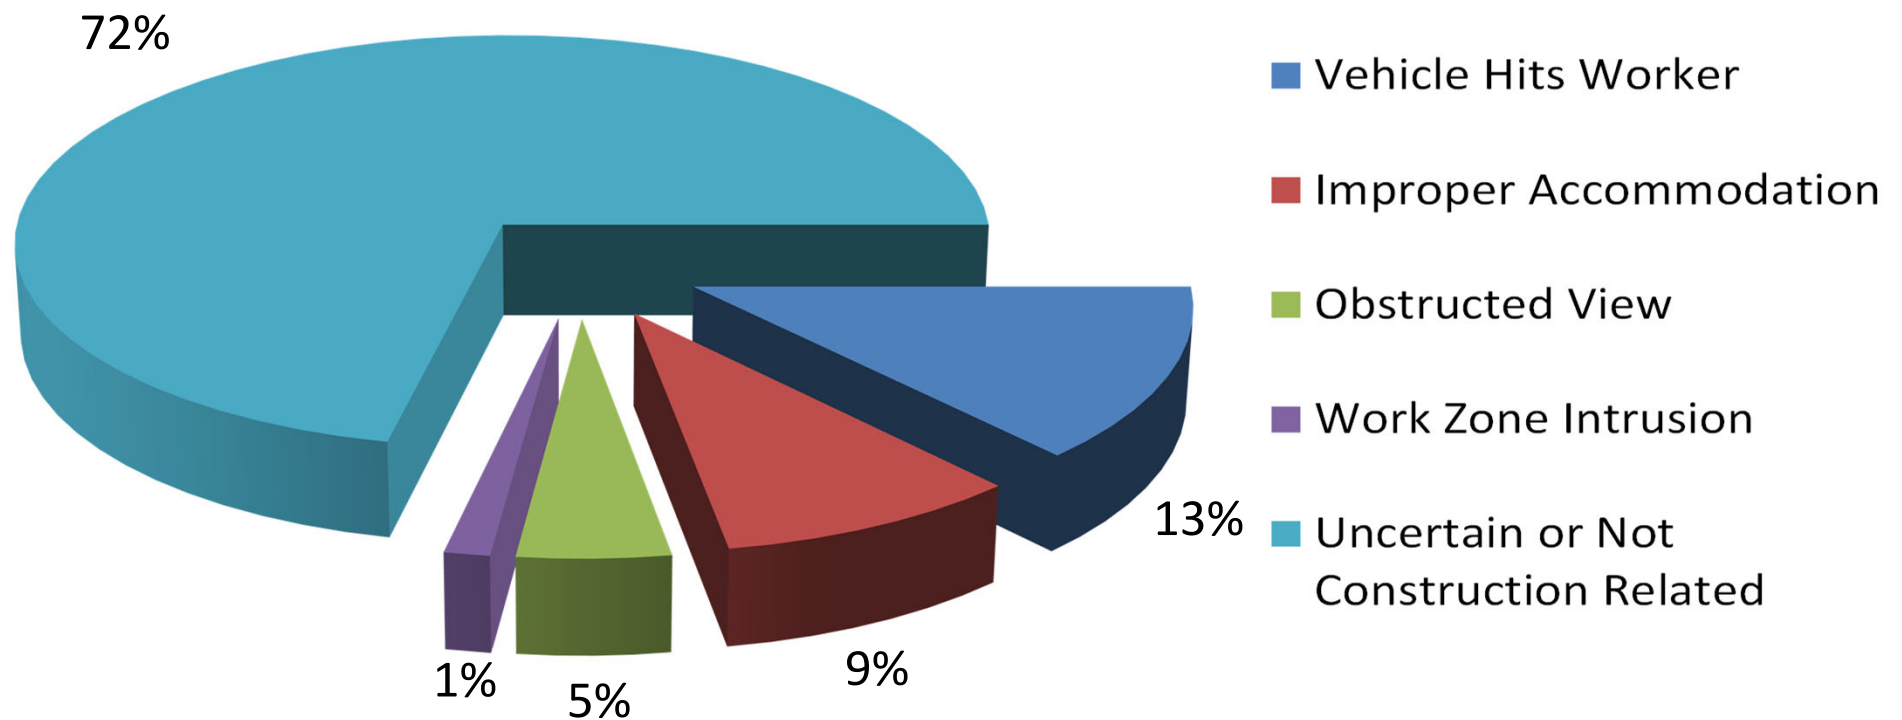
Analysis of Wisconsin 2004-13 Bike-Ped Crashes

n=219

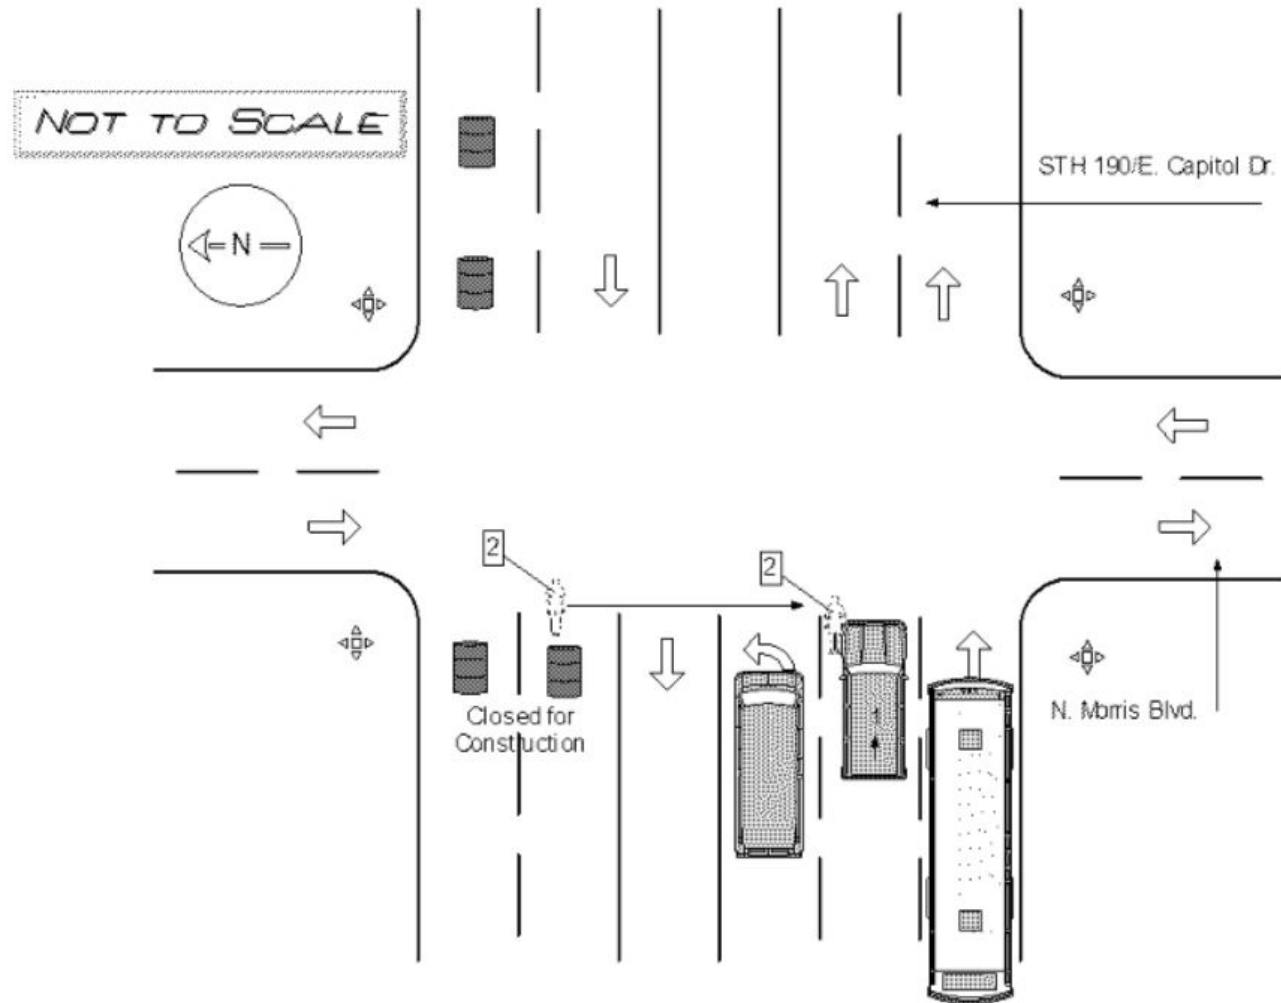
Ped/Bike Crash Example 1

Improper Accommodation

- Disorganized work zone; traffic control devices not laid out well
- Pedestrian walked across two closed lanes
- Pedestrian saw her bus arriving and ran to catch it
- Pedestrian's view partially blocked by vehicle in left-turn bay
- Pedestrian struck by fast-moving vehicle in center lane

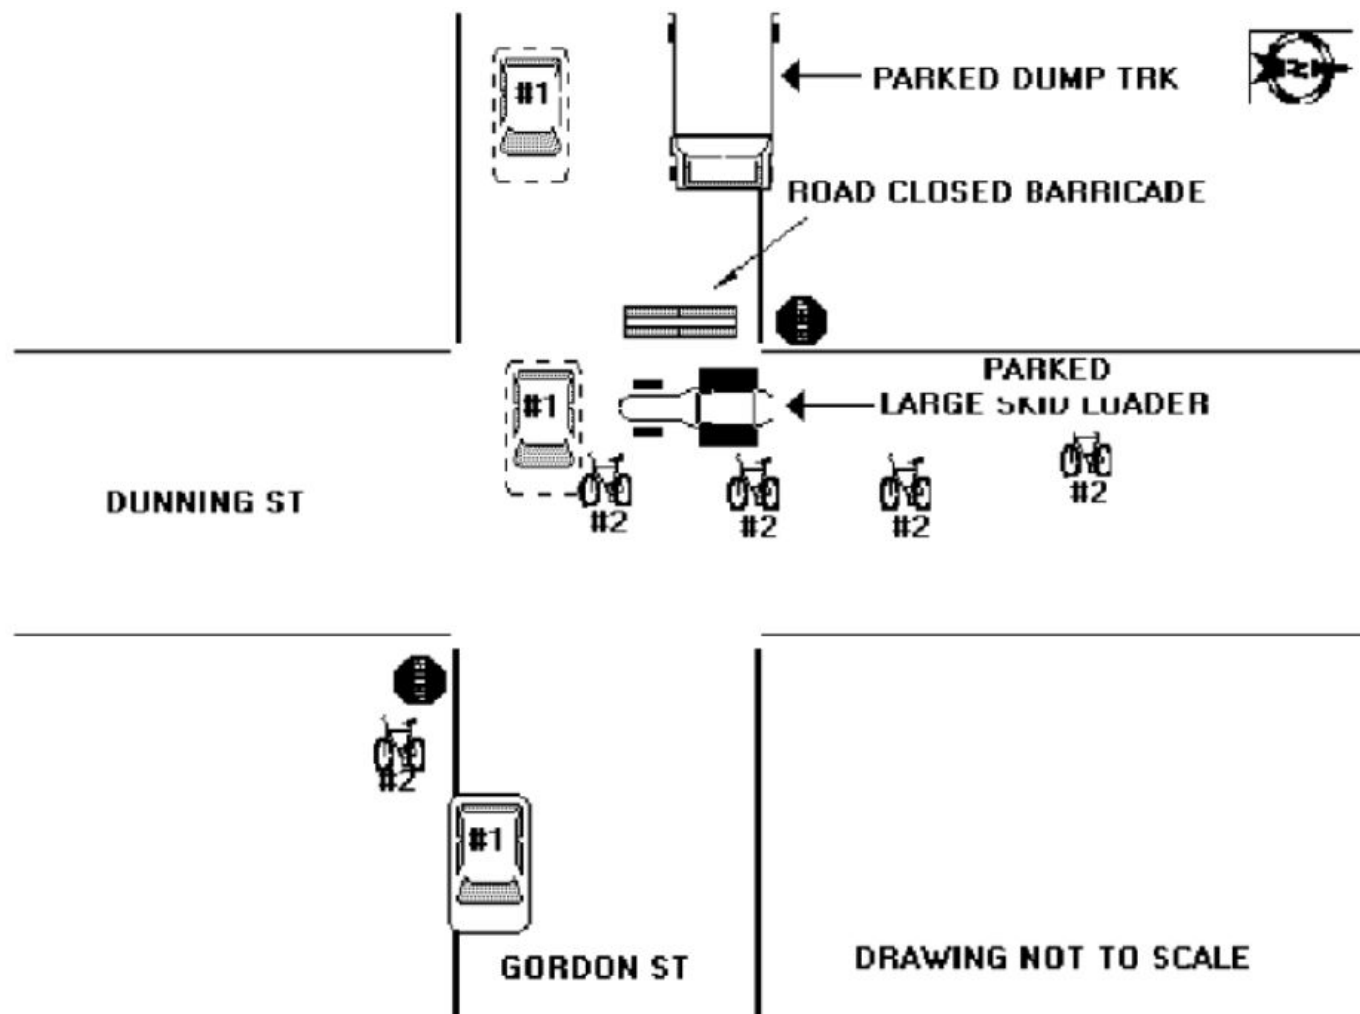
Ped/Bike Crash Example 3

Obstructed Sight Lines

- Vehicle #1 and Bicyclist #2 could not see each other due to construction equipment and barricade blocking sight lines
- Bicyclist attempted to go around skid loader and was struck by Vehicle #1

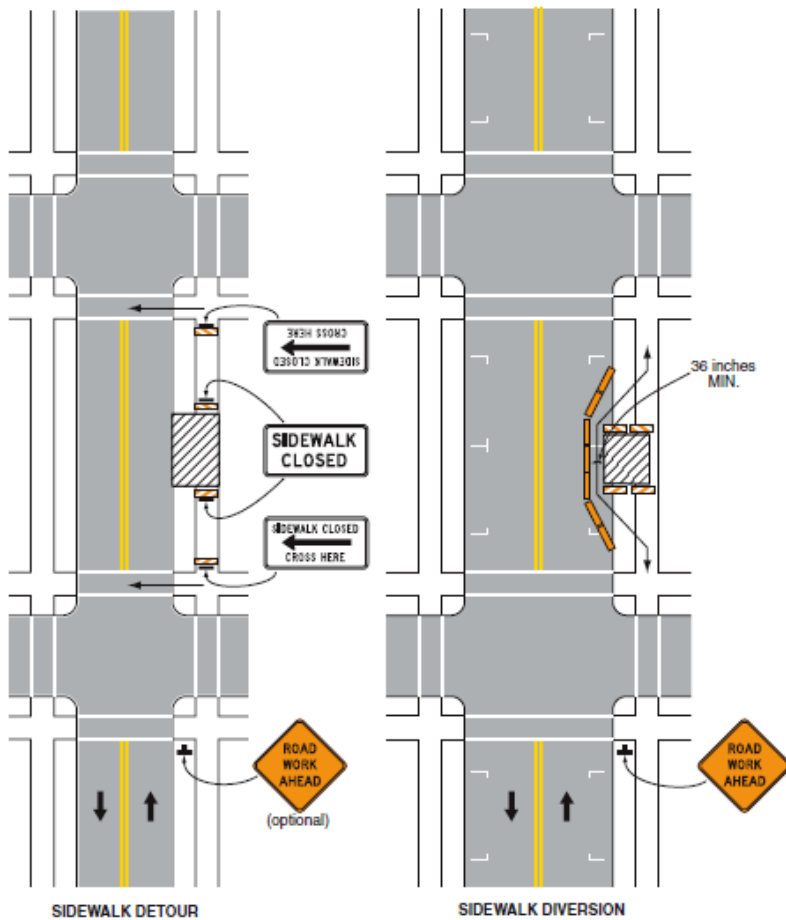
Typical Application 28

Figure 6H-28. Sidewalk Detour or Diversion (TA-28)

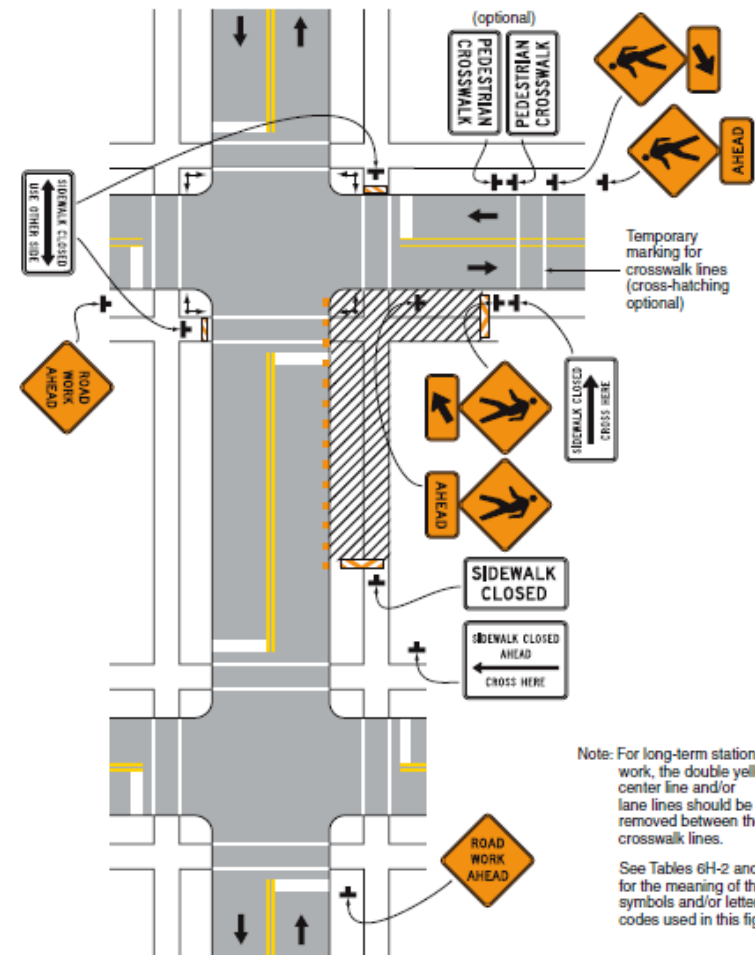
Typical Application 29

Figure 6H-29. Crosswalk Closures and Pedestrian Detours (TA-29)

Note: For long-term stationary work, the double yellow center line and/or lane lines should be removed between the crosswalk lines.
