**BLUEMOUND ROAD
CORRIDOR:
ROAD SAFETY AUDIT**

Opus International Consultants Inc.

September 2007

H-U0008.00

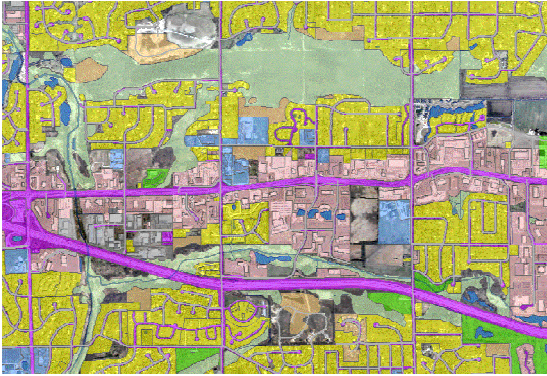
CHARACTERISTIC	DETAILS	ILLUSTRATION OR COMMENT
Classification	Major Arterial (part of USH 18)	--
Jurisdiction	Wisconsin Department of Transportation	--
Land Use	The surrounding land use for the Bluemound Rd. corridor is zoned primarily as commercial/retail or office as indicated by the violet colors. The yellow indicates residential, mostly single family with some multi-family use included.

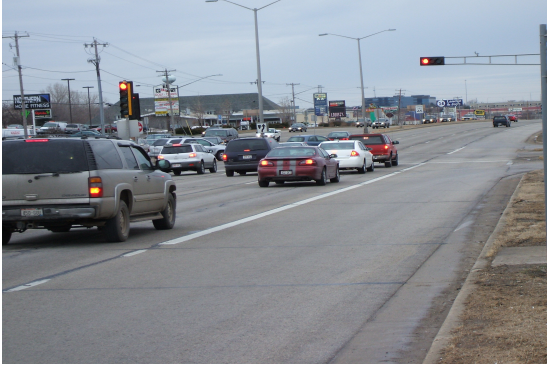
Road User Characteristics	The primarily road users for the Bluemound Rd. corridor were passenger cars most likely commuting to the mall/shops or various office locations in Brookfield and Elm Grove. Pedestrians, bicyclists and transit were also observed using Bluemound Road. Large trucks utilize the corridor to make deliveries and as an alternate route to I-94.

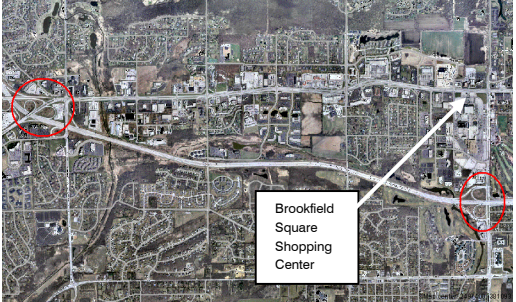
CHARACTERISTIC	DETAILS	ILLUSTRATION OR COMMENT
Influences	<ul style="list-style-type: none"> • The circle to the left is the I-94 and Barker Rd. interchange. A Park and Ride is located off the ramp. • The circle to the right represents the Moorland and I-94 interchange. • Many of vehicles utilizing the Bluemound and Moorland intersection are likely associated with retail activity near the Brookfield Square Shopping Center.

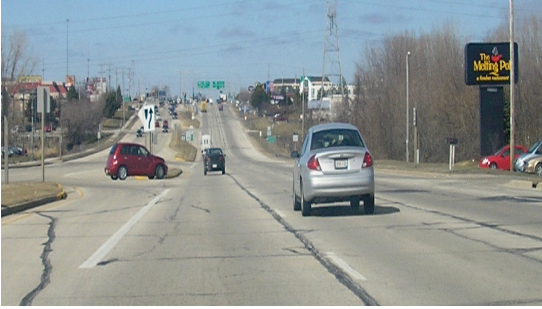
CHARACTERISTIC	DETAILS	ILLUSTRATION OR COMMENT
Median Breaks	Mid-block bi-directional median breaks are present on the corridor. There is potential for interference between median breaks and through traffic. The breaks generate accelerating, decelerating, and turning traffic close to the intersection.

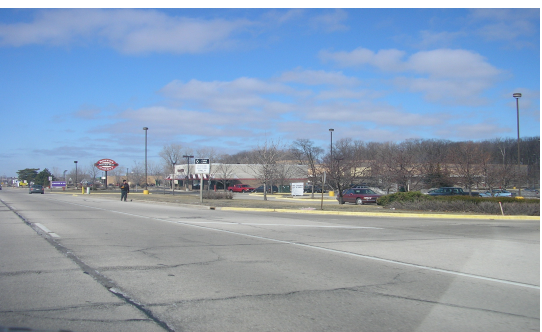
Speeds	45 mph on Bluemound Road	During site visits, traffic appeared to travel at speeds consistent with the posted speed limits.
Pedestrian Facilities	The pedestrian network is currently incomplete. A continuous sidewalk is located on the south side of Bluemound Road. On the north side the sidewalks are present in some areas while not in others. This may be due to a lack of jurisdictional cooperation.

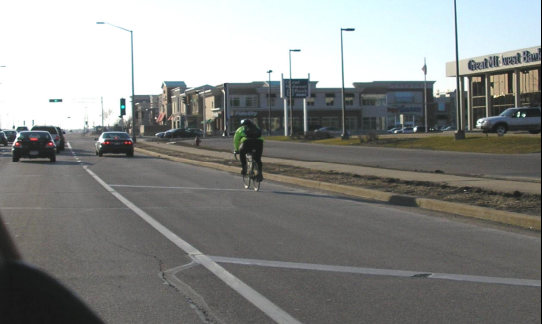
Bicycle Facilities	Designated Bicycle Facilities such as lanage do not currently exist. Bicyclists were observed riding either in right-lanes of Bluemound Rd. or on the sidewalks.

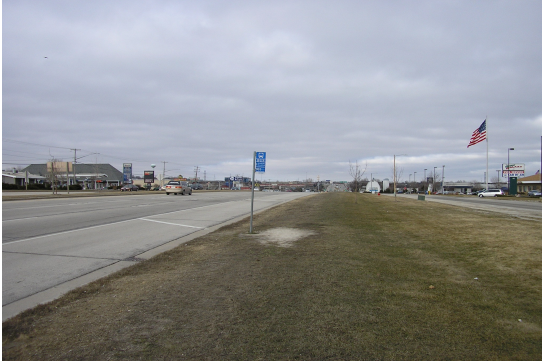
CHARACTERISTIC	DETAILS	ILLUSTRATION OR COMMENT
Transit Facilities	Waukesha County Metro buses are present along Bluemound Rd. Transit facilities consist primarily of signage. A park and ride lot is located at the intersection of Barker and Bluemound.

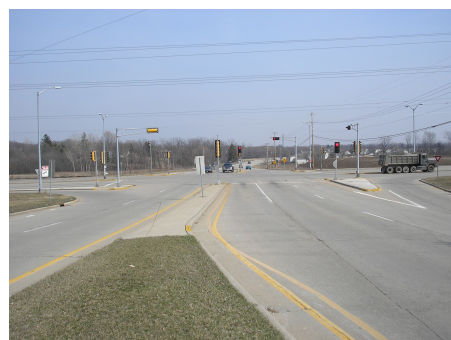
Example of a right-turn channelization island with the proposed configuration (STH 59/164) and Cleveland in Waukesha County

Safety Issue 1a: A high frequency of rear end right-turn crashes are occurring on northbound Barker as a result of limited sight distance due to the shape of the right-turn channelizing island.

Safety Issue 1a Description: A review of the crash data for the intersection of Barker and Bluemound indicated that 49 rear end crashes were occurring within the northbound right-turn channelization island. The first issue identified at the channelization island is the intersection sight distance between right-turners and approaching through traffic. The combination of a horizontal curve on Bluemound and the drivers requirement to look back impacts the sight distance.

Safety Issue		Suggestions
1a	1b	
√	√	<p>1. <i>Reconfigure the right-turn channelization islands to reduce turning radius</i></p> <p>Realigning the right turn channelization islands (<i>as shown on the right</i>) to reduce the turn radius, will reduce the unexpected stops and have the added benefits in terms of accommodating safer pedestrian crossings. It is noted that a redesigned right-turn channelization island must still be able to accommodate trucks and buses.</p>

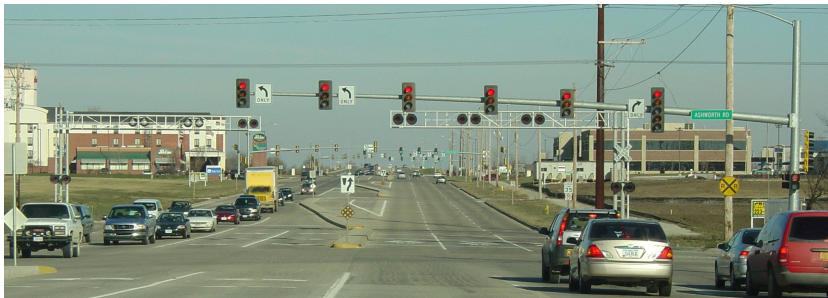
Safety Issue 7 Description: The use of a single overhead signal head limits signal (and intersection) conspicuity for drivers approaching the intersection, and may limit signal visibility for drivers whose view of the single overhead display is compromised by a tall vehicle (such as a truck) ahead, or affected by a bright rising or setting sun. The risks associated with limited signal and intersection conspicuousness is greatest at the intersection with Barker Road, where drivers' view of the intersection on several approaches is limited by vertical and horizontal curves. Drivers who fail to observe the signal display increase the risk of angle and rear-end collisions. The risk is also increased for older drivers, whose visual and decision-making abilities are reduced.

1. *Provide a redundant signal display on each approach.* The use of multiple overhead signal displays on a single approach enhances signal conspicuity, provides redundancy in the event of signal failure or damage, and may improve signal visibility. Redundancy may be achieved by providing multiple signal overhead heads (such as one signal head over each approach lane).

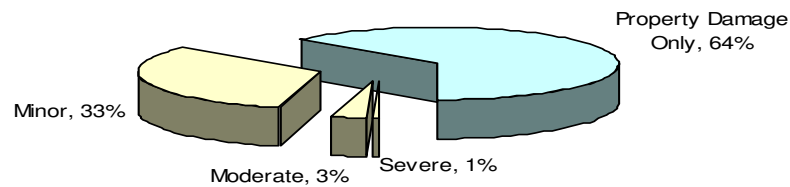
FIGURE A-1 COLLISION SEVERITY DISTRIBUTION

Police collision reports were provided by the Wisconsin DOT, and were supplemented by a collision data summary. Annually, 199 collisions were recorded at or near intersections, while 120 collisions were recorded at mid-block area. As summarized, about 37 percent of the collisions resulted in at least one non-fatal injury. The remainder of the collisions involved property damage only. No fatalities were reported during the study period.

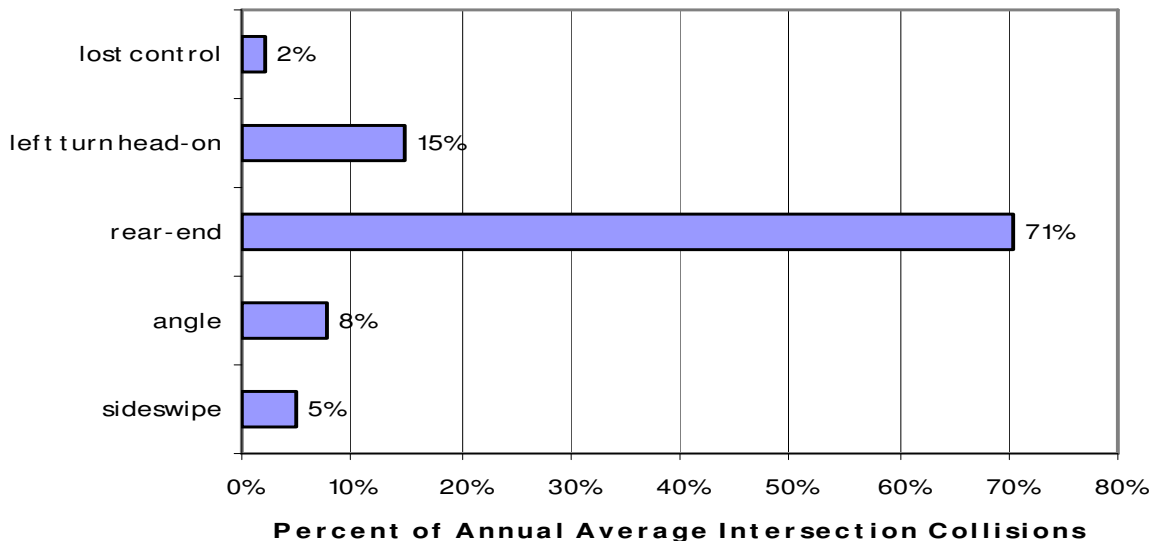
FIGURE A-2 Intersection Collision Type Distribution

Collision type distributions are summarized in FIGURE A-2/A-3 and TABLE A-1/A-2. A review of the collision types shows that rear end collisions predominated, representing 71 percent of intersection collisions and 29 percent of mid-block collisions. Sideswipe, angle, and left turn collisions represented 5 to 15 percent of reported intersection collisions and 16 to 29 percent of reported mid-block collisions.
