USH 41 EXPANSION -WINNEBAGO COUNTY:

ROAD SAFETY AUDIT

November 2007

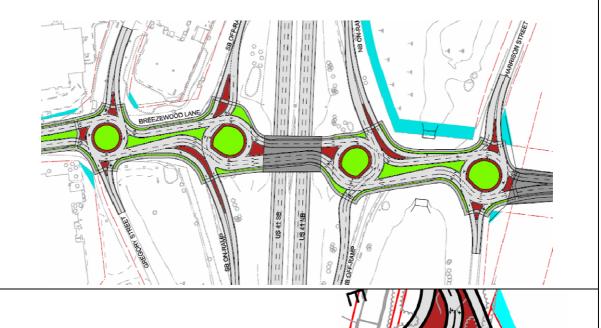
Use of innovative interchange design: The design includes sixteen roundabouts at interchanges and intersections along USH 41, all of which are planned to improve both safety and operations. Although some safety issues associated with roundabout configurations have been identified, the use of the roundabouts should reduce both the potential for high-speed conflicts and delays at associated at-grade intersections. Roundabouts result in a moderate reduction in crash frequency, especially for left-turn and angle crashes, and a high reduction of the severity of all crashes.

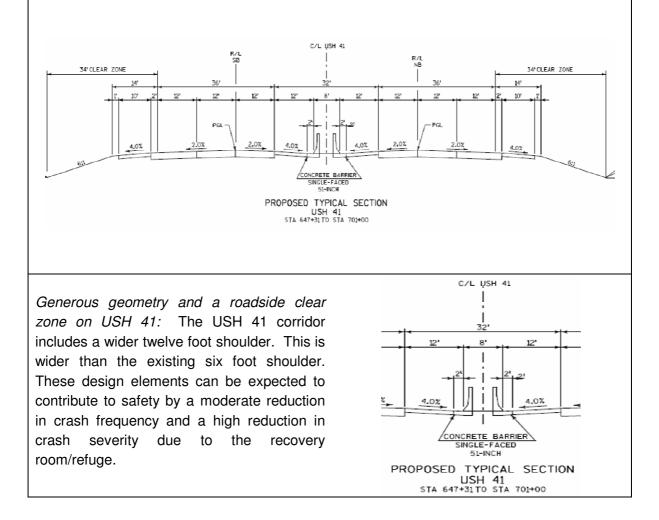
Median barriers: USH 41 in Winnebago County was identified¹ as having a high number of median crossover crashes. The implementation of continuous concrete median barriers on the corridor should significantly reduce the number of median crossover crashes and their severity throughout the corridor. Specifically, the median barrier will help to prevent head-on crashes associated with median crossover crashes.

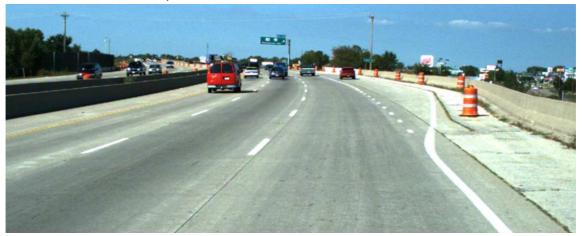
Ramp upgrades: Auxiliary lanes and longer acceleration/deceleration lanes at ramp entrances and exits. These improvements should help to reduce rear-end, weaving, and truck crashes near the ramps.

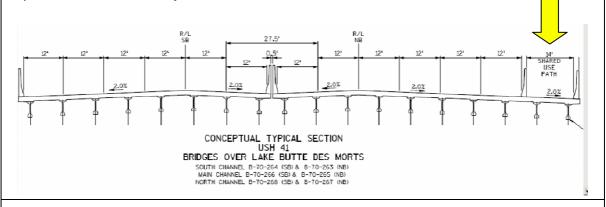
Non-motorized facilities: The planned improvements will provide a more complete and continuous network of sidewalks near all roundabout interchanges. Crosswalks and bicycle facilities will be provided at each of the intersections. A shared use path will also be provided on the USH 41 Bridge over the Lake Butte des Morts. These improvements are expected to improve comfort and safety for non-motorized road users.
